# Ceramic capacitors: recent in-orbit failure and proposed way forward

Adrià Escoda Marches, Joaquín Jiménez Carreira, Léo Farhat  
European Space Agency (ESA), European Space Research and Technology Center (ESTEC), Noordwijk,  
The Netherlands

## CAPACITOR FAILURE LEADING TO IN ORBIT SATELLITE LOSS

### Copernicus Sentinel 1B

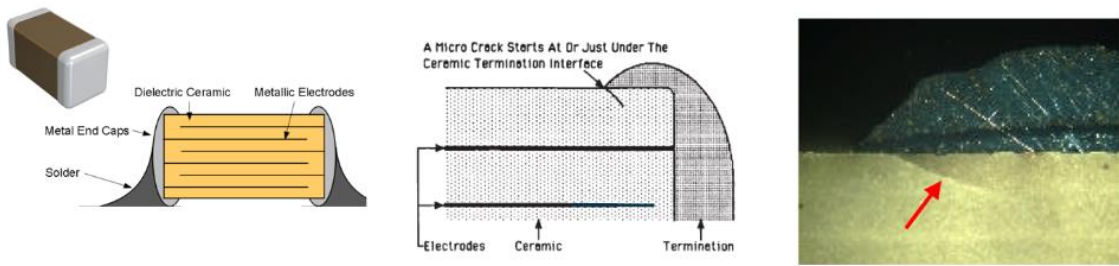
Fig. 1. Microcrack formation

Detailed investigations were performed to understand the root cause of the CAPS anomaly, with the identification of 18 potential failures. The most probably root cause is related to a potential leakage of a ceramic capacitor. This capacitor had to be replaced as a result of a non-compliance detected during manufacturing and testing phase. For the repair process, the capacitor was assembled using direct wiring soldering process. At the time, neither reworking nor direct wiring on a ceramic chip capacitor were forbidden by the applicable product assurance requirements. Rework processes (or reprocessing) are no longer authorized following revision of the applicable ECSS standard in 2017 (ECSS-Q-ST-70-38C rev1). In addition, since 2019, the Memo ESA-TECQTM-MO-1143 also forbids direct wiring of type II ceramic chip capacitors and recommends the use of dedicated patch boards. This has been included in the recent ECSS-Q-ST-70-61C, issued on 8<sup>th</sup> April 2022.

The failure mechanism consists of an on-chip heat distortion that was caused by direct wiring soldering, which resulted in the formation of a microcrack (Figure 1). The crack starts at the weakest point at the interface between the ceramic and the end of termination. After several thermal cycles, due to the CTE (Coefficient of Thermal Expansion) mismatch, the crack propagates (Figure 2).

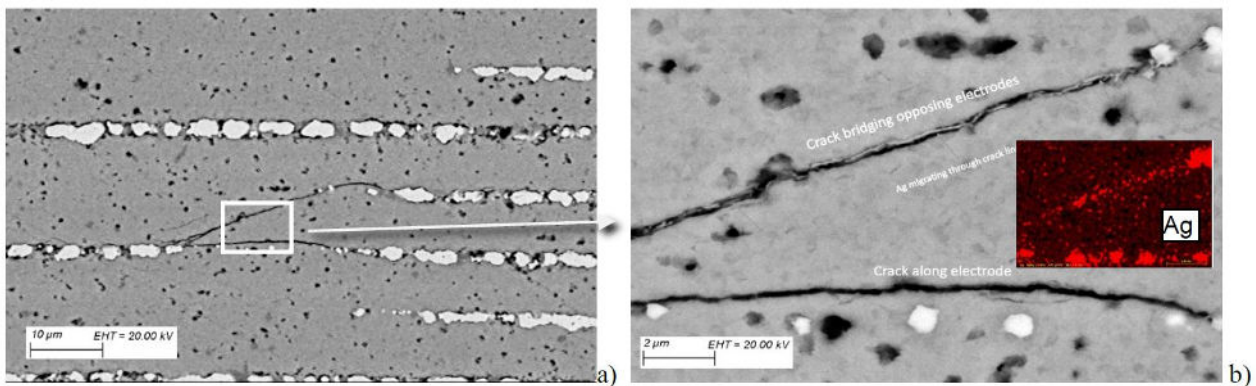
Fig. 3 Electromigration in PME capacitors.

Diffusion and migration of Ag into dielectric layers from inner Ag or Ag/Pd electrodes (present in PME capacitors) might cause a problem for long-term reliability. In presence of moisture, silver is a susceptible material of electromigration, and

for this reason, cracking of PME (Precious Metal Electrode) capacitors creates a high risk of electricity failures, such as short circuit. The described phenomena are shown in Figure 3.

An overall (a) and close-up (b) views of a shorting crack in 0.1  $\mu\text{F}$  16 V PME capacitor. The part was tested at 6 V and started showing increased and unstable leakage currents after 110 hr at room temperature and then failed eventually short circuit due to silver electromigration after 50 hr at 60  $^{\circ}\text{C}$ . (Pictures courtesy of Ron Weachok, Jacobs Technology Inc.)

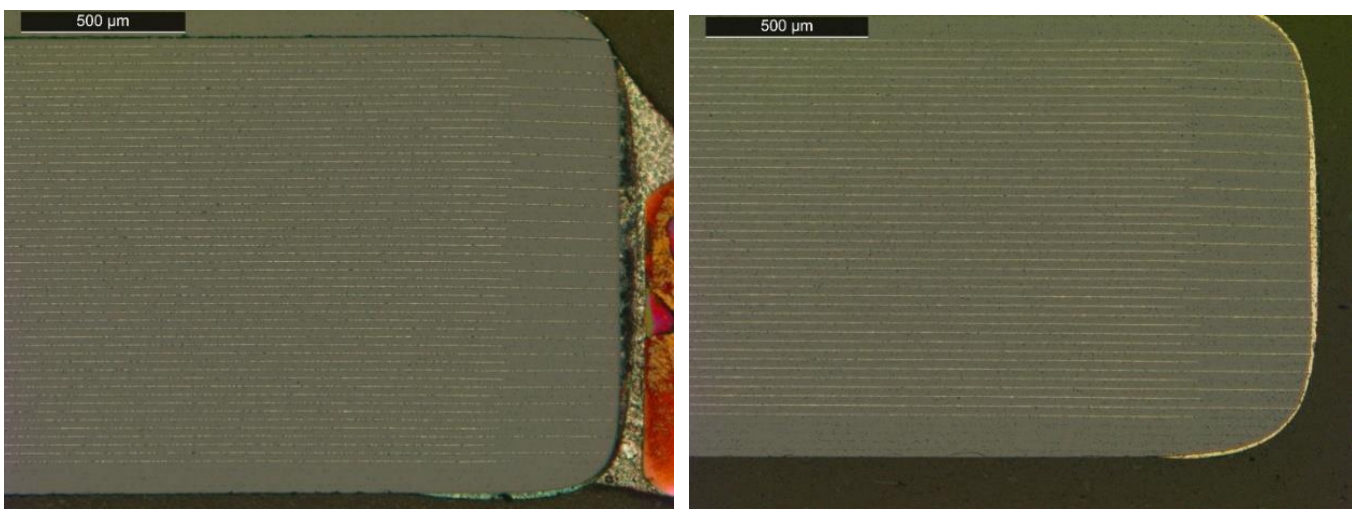
Fig. 4. Microsections showing a comparison of the internal design between the CKR06 (left) and CKS06 (right) capacitors.

All the failed capacitors detected, seven in total, were submitted to thorough failure analysis investigations (electrical measurements, infrared thermography and microsections). This analysis confirmed that the failure mode of all failed capacitors was an electrical short-circuit. The failure is caused by cracks in the active area of the capacitors. These cracks,

mainly originating from lead side and propagating to the active area, create a path through which the inner electrodes' metal (mainly silver) starts to electromigrate. Eventually, opposite electrodes inside the active area of the capacitor end up electrically connected. This has a direct impact on the insulation resistance, drastically diminishing it with time – even after several years – and finally leading to an internal electrical short-circuit.

However, the most probable of them all is the CKR06 component's internal design (a relatively large number of electrodes with relatively thin dielectric layers) and manufacturing processes (i.e., sintering, pressing, internal soldering, etc.). This makes the capacitor particularly susceptible and sensitive to cracks under thermal, mechanical and voltage stresses.

In general terms, the CKS06 internal design seems to be more reliable than the CKR06. The CKS06 type has 10 fewer internal electrodes than the CKR06 type. On top of this, the distance between internal electrodes, the distance between the active area and the external surface of the ceramic, and the distance between the end of one internal electrode and the termination, are all in average larger in CKS06 than in CKR06. All this contributes to a relatively lower probability of the appearance of cracks, due to a more robust internal design. Figures 4 and 5 show the differences between both capacitors.

The ESA Alert recommends, as a preferred option for new procurement, to use the space grade alternative capacitor MIL-PRF-123/2 CKS06 1 $\mu$ F, 50V (part number M123A02BXB105KC) because of the part design and lot specific testing required by this high reliability specification.

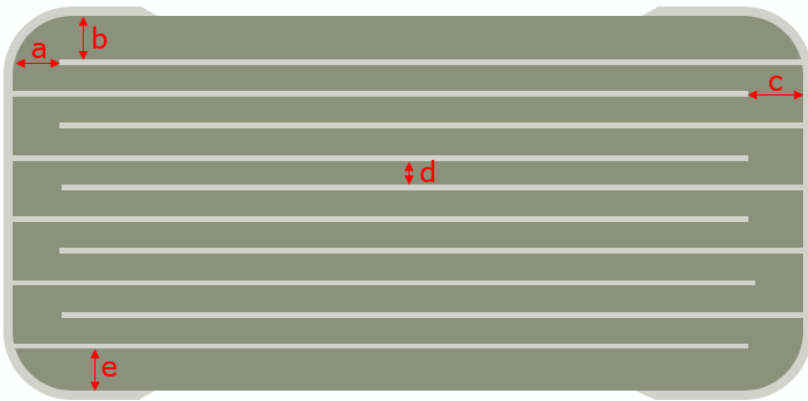
Fig. 5. Schematic representation of a microsectioned ceramic capacitor. The table shows the relative dimension differences between the types CKR06 and CKS06 in percentages.

Dimensions	Length
	CKS06 > CKR06 (%)
a	12%
b	20%
c	0%
d	11%
e	25%
