New Whiskers Phenomena?

Jean Pascal Michelet: Supplier Quality Assurance, Passive Components Expert,
VALEO Créteil France _ jean-pascal.michelet@valeo.com

Introduction

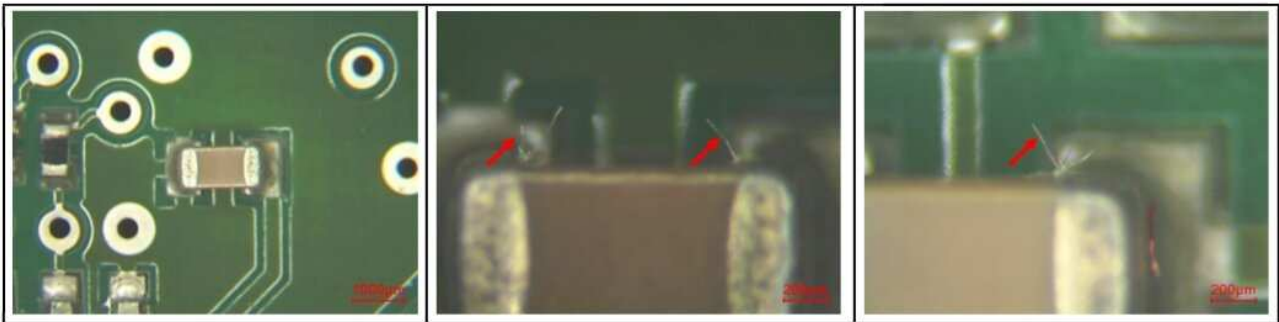
Fig1: Observations of the whiskers. Lengths are measured up to 225µm. Whiskers have tubular shapes. They are located on the sides only, never on the top (not possible to observe the bottom). Whiskers are located between the Tin plated termination and the flux rise.

The shape of these whiskers is not conventional and is not described neither by the Nasa [3] nor by Jedec [2]. Some hollow whiskers were reported [4], [5], We did not find any document on Tubular whiskers growth on Electronic components. For us it is the first observation of such structure.

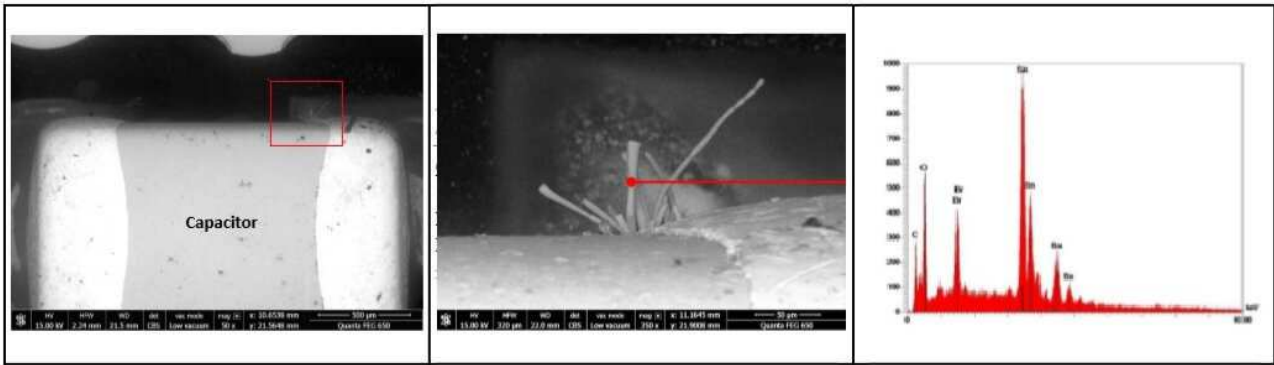
Fig2: EDX analysis evidenced Tin, Bromide, Barium and Oxygen. Barium is coming for the BaTiO₃ ceramic from X7R MLCC. Bromide origin is unknown.

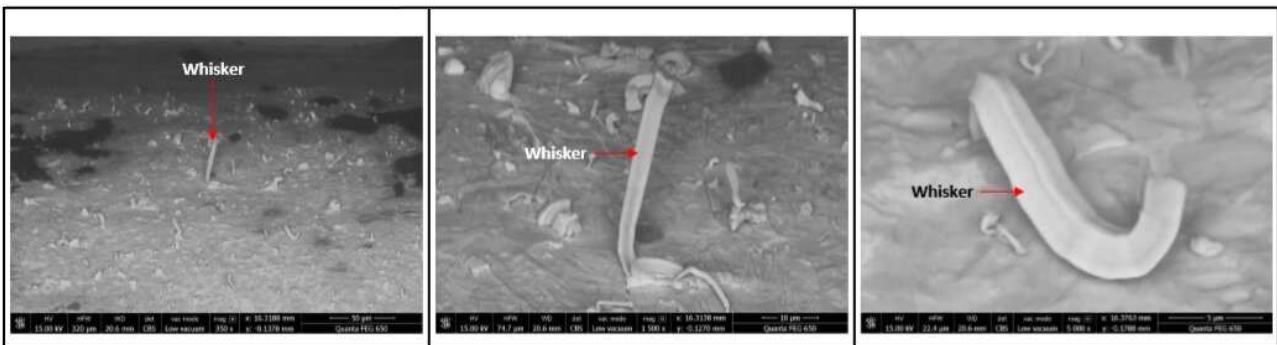
Fig3: The shape of “standard” Whiskers was observed on another component terminal and compared with those found on the MLCCs.

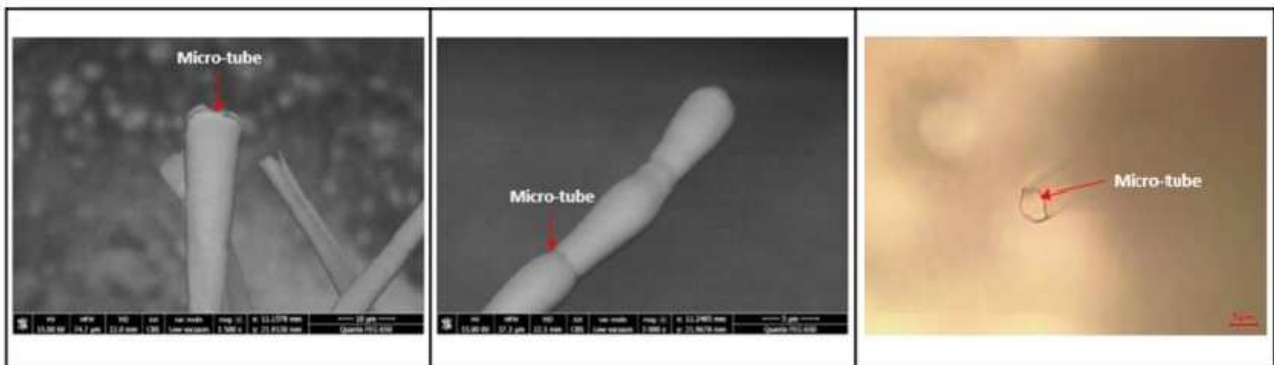
Fig4: The whiskers in question are hollow like micro-tubes. They are transparent and very brittle.

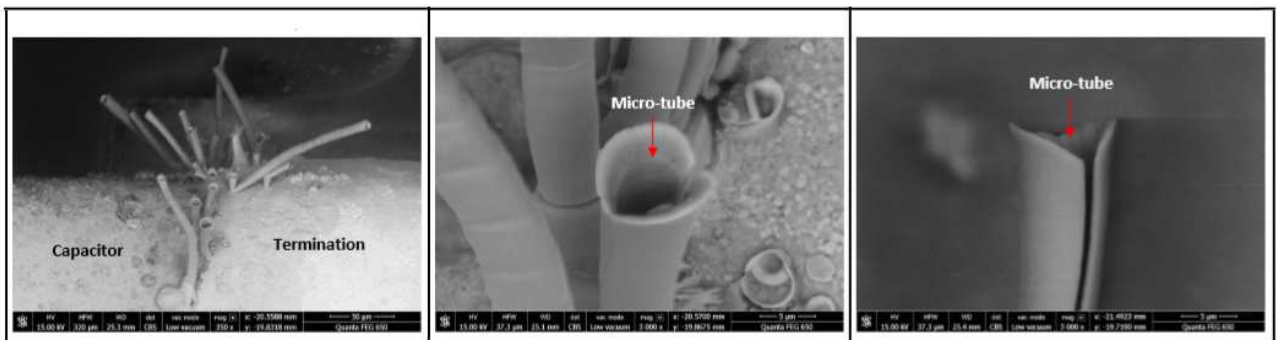
Fig5: The micro-tubes are like bamboo canes with a succession of segments. Some have their end slit on the side.

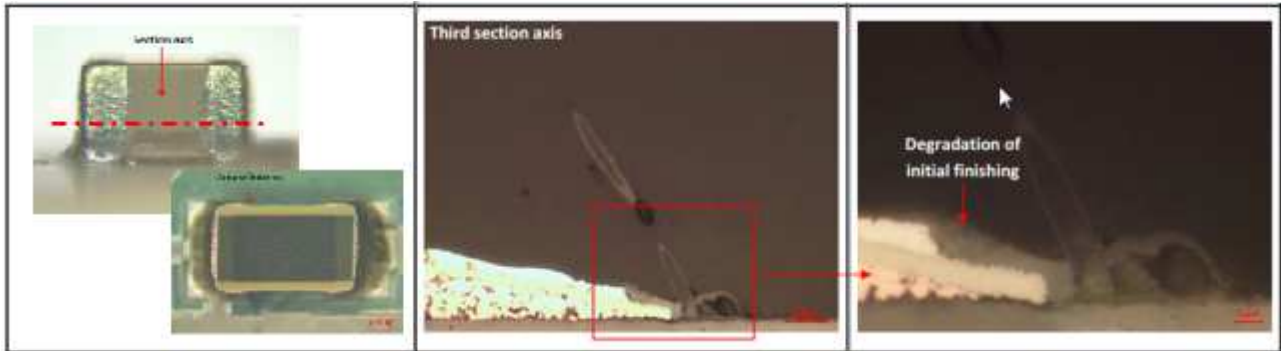
A cross section was done in the horizontal plane of a MLCC at the maximum flux rise where the Whiskers grow .

Fig6: The extremity of the termination evidenced Tin over Nickel and Copper. Tin is partially oxidized (grey color) like whiskers. In the section plan the tubular shape is evidenced. Whiskers growth is on the ceramic nearby or in contact with the Tin edge of Tin layer.

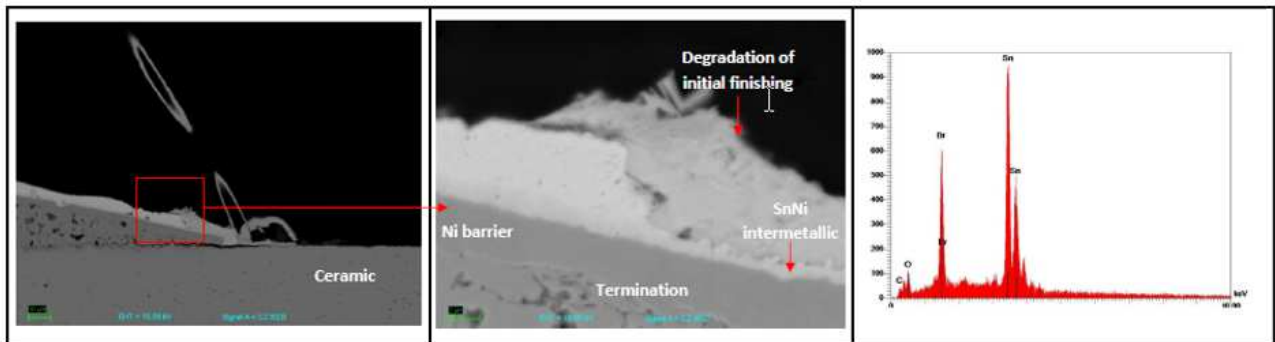
Fig7: The edge of the Tin layer is oxidized by Bromide. The crack between the ceramic and the termination is a minor polishing artefact. Bromide origin was identified as coming from the Solder Flux.

Growth mechanism is suspected to come from a localized corrosion process by a Bromine acidic solution from the Solder flux residues and the moisture from the humid atmosphere of the damp heat test.

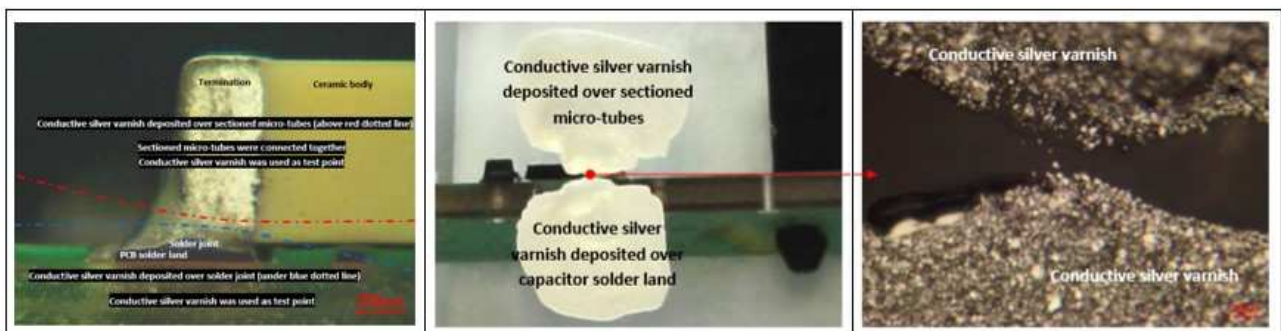
Fig8: cross section in the vertical plan contacting the MLCC solder and the whiskers ends. Both were contacted with

Silver epoxy. The realization of the microsection as much as the precise deposit of the silver lacquer are difficult to achieve.

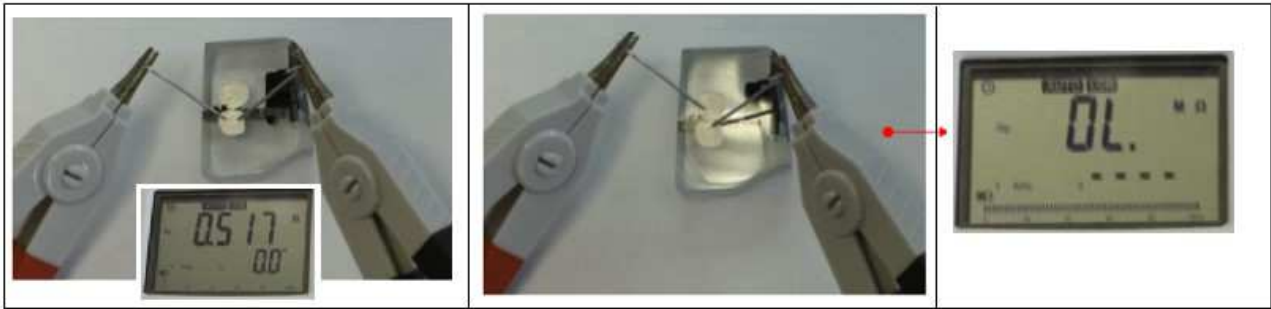
Fig9: Verification of the contact, and measure 2 probes. The whiskers are not conductive (or not contacted). A verification was done by contacting both ends of a single whiskers.

We demonstrated no risk of leakage or short circuit.

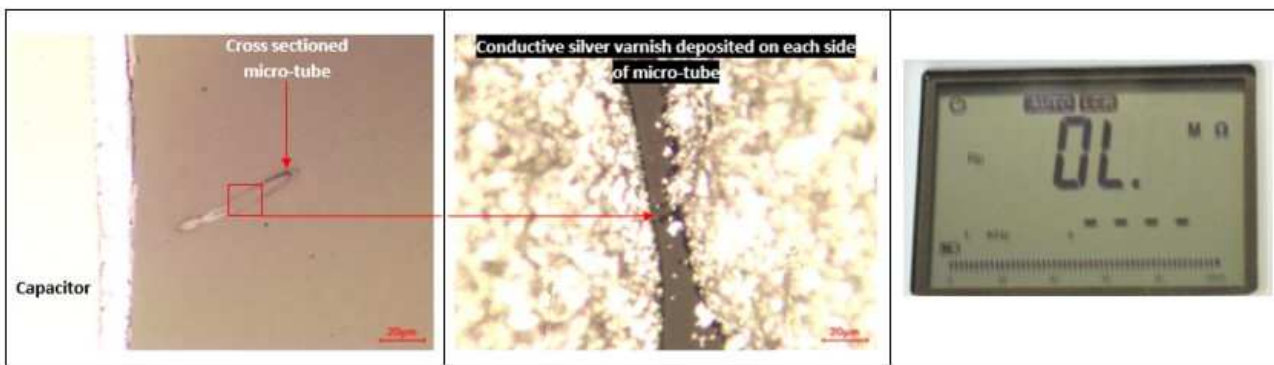
Fig10: Verification of the whiskers resistance done by contacting both ends of a single whiskers: not conductive.

Hollow Tin Whiskers are transparent, very brittle and not conductive.

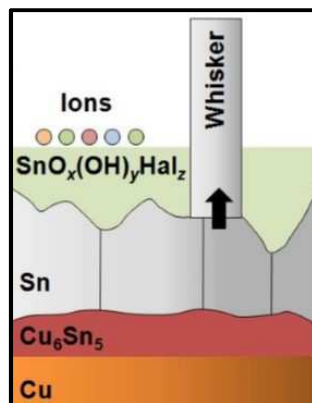
Tin hydroxide chloride $[Sn_3O_2(OH)_2 \cdot xCl_x]$ was reported to be intermediate corrosion products on reaction from $Sn \rightarrow SnO/SnO_2$ (depending on pH and presence of chlorine halogen) [7]. A similar Tin hydroxide bromide could have been the intermediate corrosion product to give rise to the tin oxide hollow whisker encountered:

Fig11: corrosion of Tin layer with intermediate Tin hydroxide halogen [7]

This localized corrosion process in presence of halogen ion (bromine) could have been at the origin of the tube shape observed.
