Climatic Reliability of Electronic Parts – Solution of the Challenge

Protection of electronic assemblies against electrochemical migration (ECM)

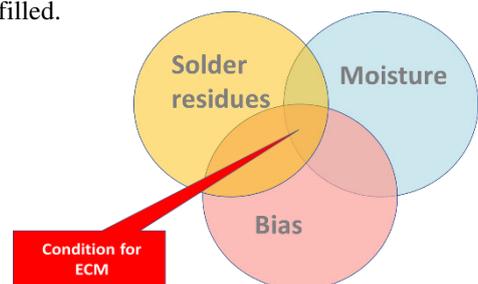
Fig. 1 Conditions for electrochemical migration

Metal ions can be generated and transferred only if three conditions are fulfilled.

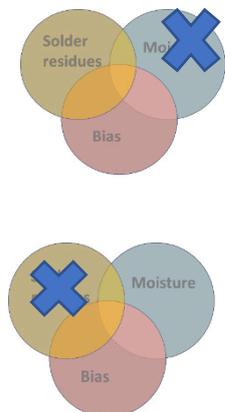
Fig.2 Possibilities of ECM prevention

There are two ways how to limit the risk of ECM.

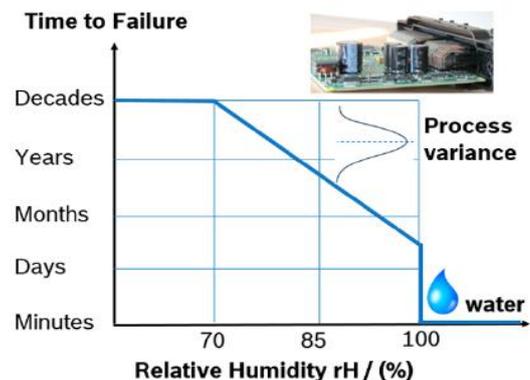
Fig 3: Time to failure dependent on moisture exposure of the assembly (Source: BOSCH) [2]

Resin protection against moisture is not absolutely gas-tight. Every organic material has its moisture permeability. After some exposure to higher rH levels, the humidity can reach ionic active residues. Long-term research done at Danish Technical University (Mr. Rajan Arbat and his team [1]) showed that the increasing rH over 70 – 75% is critical at many different flux residues compositions. Also, the hygroscopicity of different activators in the flux system has a significant role in the induction of ECM. Also, intensive studies from BOSCH [2] confirm a similar situation, that exposure of assemblies to relative humidity higher the 70%rH and ionic activity of compounds in flux residues has a significant role in starting ECM.

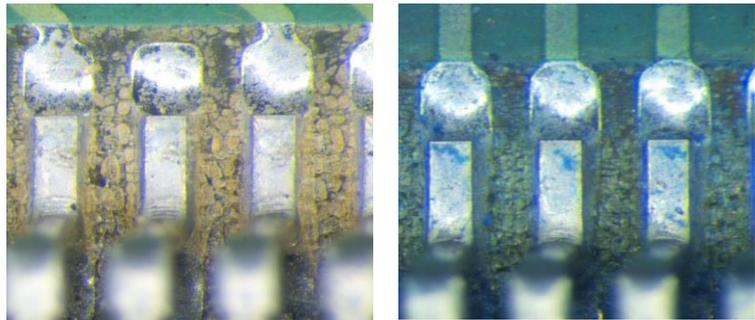
Fig.4: NO-clean assembly after thermal cycling in the field and after a test for weak organic acid radicals (blue-right side)

Additionally, the hard and brittle resin does not remain compact due to thermal mismatch and thermal cycling of all parts of the electronic assembly. Pictures from the field show the consequences of such thermal cycling after five years of operation. Exposure of this assembly by the chemical indicator of weak organic acid radicals showed an intensive blue discoloration. Such a result is evidence of active ionic compounds. When exposed to humidity and bias, such assembly is ready for ECM immediately.

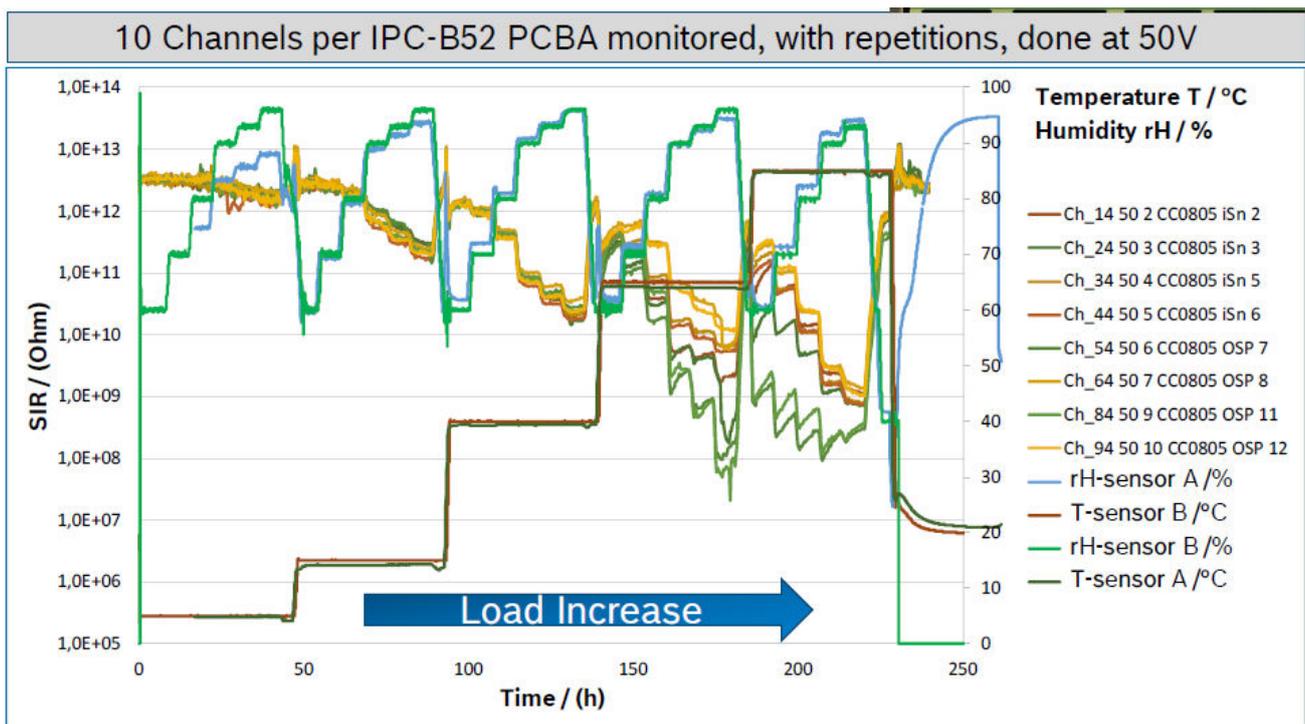
Fig 5: Record of Stepwise T, rH SIR test on B52 test board (source BOSCH [2])

It shows that areas at specific components cannot return to their initial surface resistance after several cycles of exposure to higher humidity and temperature. The reason is that even the well-composed no-clean flux released some ions after repeated exposure to a high moisture level.

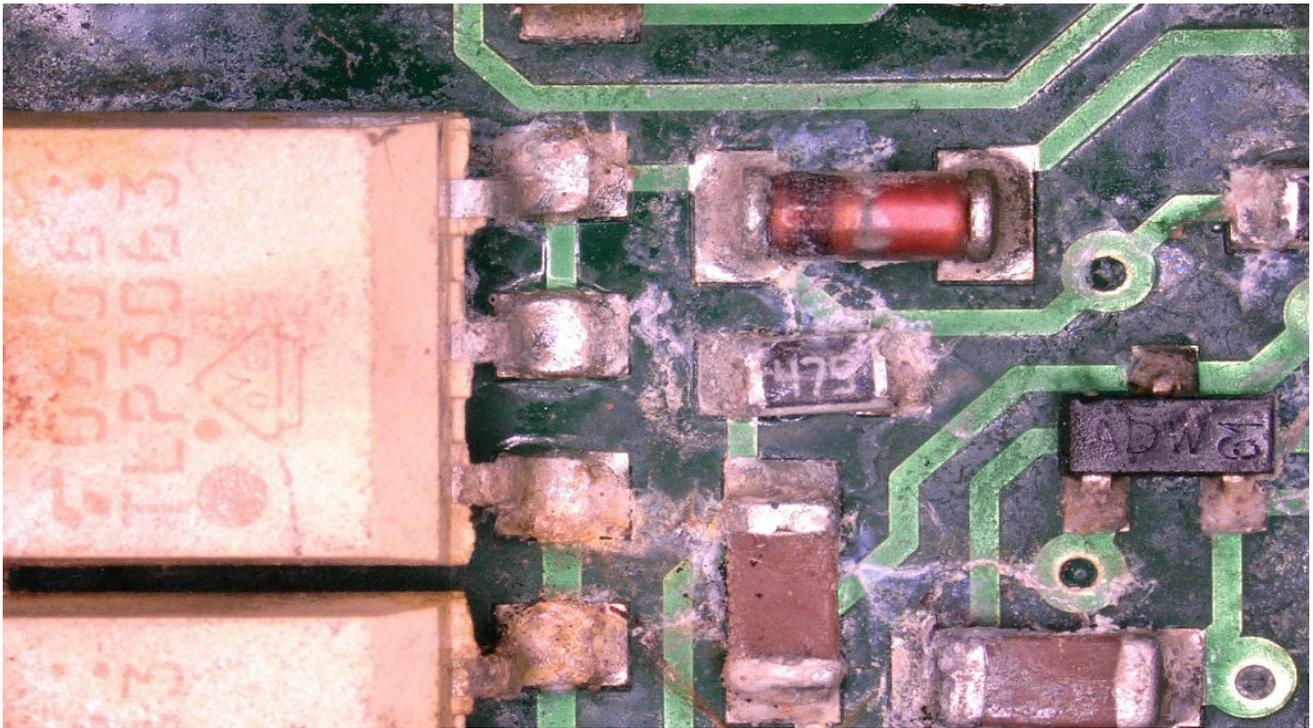
Fig.6. Fatal damage of PCBA due to high moisture and condensation (not cleaned board)

The following picture is a practical example of the consequences of high moisture (condensation) on the PCBA. The photo comes from repairing the control system of the heat pump for domestic heating. The device was installed inside the house in a room with moderate temperature and no significant temperature fluctuation. Nevertheless, the moisture condensation on the assembly surface during the rainy season caused dendrite growth. The place of installation was not in the tropics country but in the middle of Europe. PCB was not cleaned. Thus the ionic residues activated the ECM.

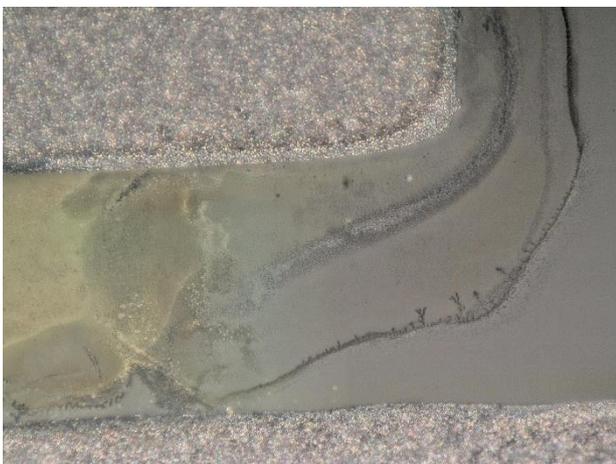
Fig.7 Precipitates caused by leakage current

Such leakage currents usually are not visible. Using Glass test boards, we can see the orientation of precipitates in the electrical field between the cathode and anode. The low current causes such orientation. For building a dendrite, there was not enough potential in the area. Technique by glass test board is optimal for studying such an effect because it is absolutely not destructive, and even the finest structures can be visible.

In picture 7. there is a capacitor from a sensor that should watch the presence of the textile fiber in the weaving machine. The atmospheric conditions inside the machine are 40°C, 65%RH. The sensors were found not reliable after some time. The reason was a capacitor and low surface insulation resistance around it. Visibly, there were no traces of any migration. However, the indicator of carboxylic groups has shown a presence of activators, which were not de-composed adequately during the soldering process. (not cleaned assembly)

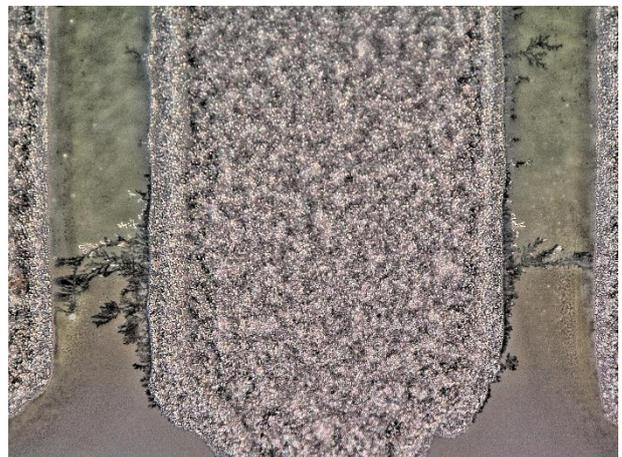
Fig. 8. Dendrites grown between poles of combs at not thoroughly cleaned flux residues

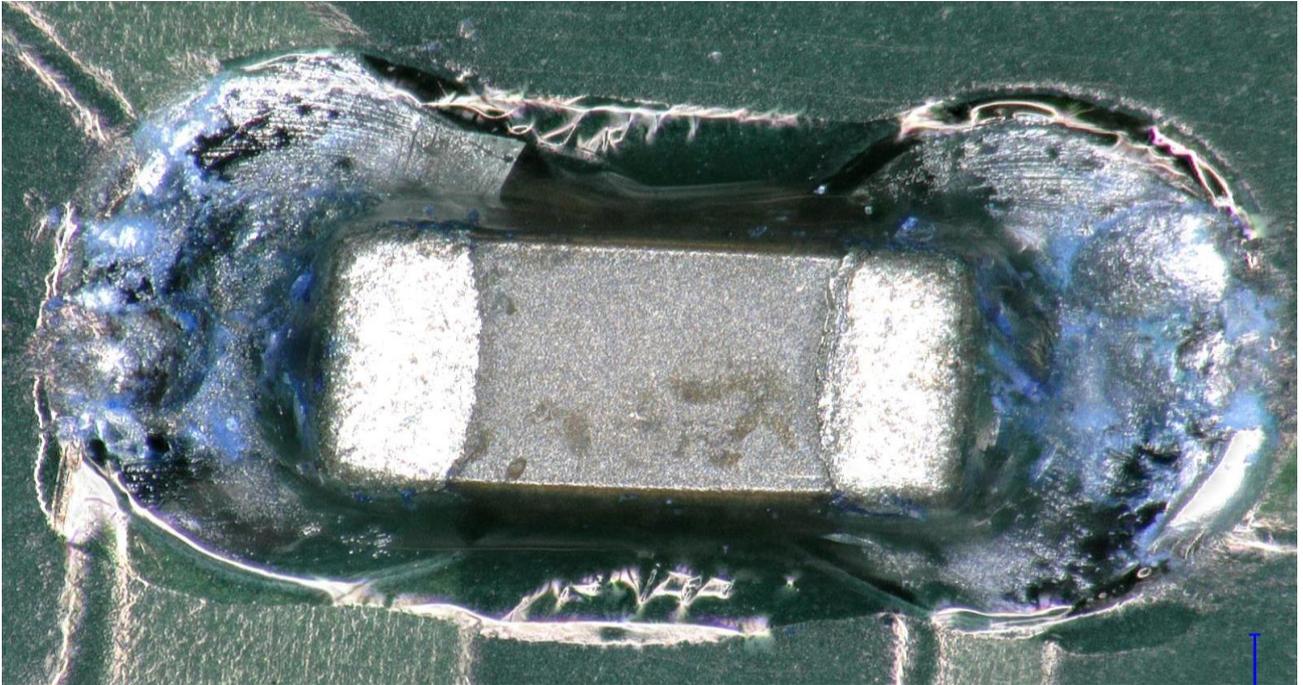
Fig 9. Still present activators in flux residues (blue discoloration by a chemical test of carboxylic radicals belonging to WOE (weak Organic Acids)

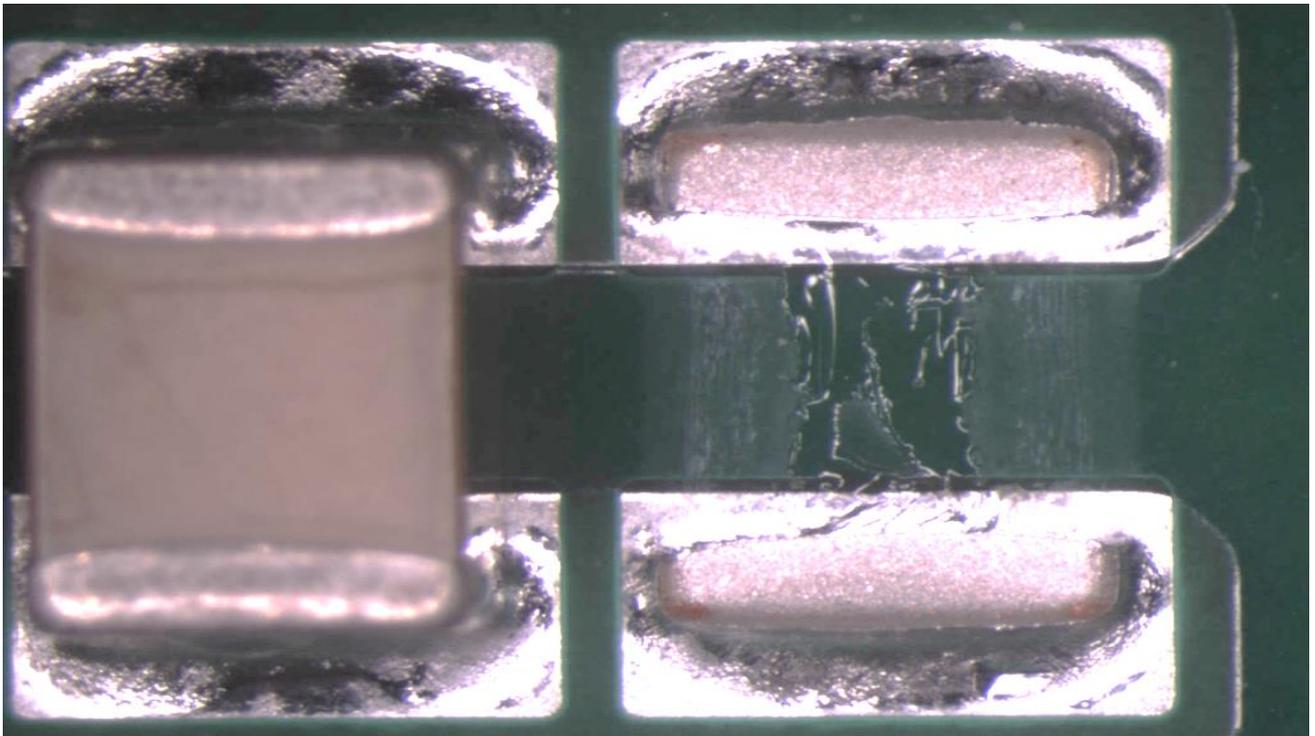
Fig.10. Uncompletelly cleaned space (gap) under MLCC capacitor

Due to limited mechanical cleaning action under components, some residues are often left there. In picture 7, we see two areas. So far, no dissolved flux residues - these might not be critical at the beginning of the lifetime of the assembly. Later, after breaking the flux layer by thermal shocks, it can cause ECM. The grayish areas, however, are dangerous immediately after such incomplete cleaning. These can be salts of organic acids and metal oxides produced during soldering. Also, it can be a less soluble part of the resin, forming a rough surface (therefore of a white color). In both cases, this is a risk for an assembly. Even non-ionic residues with a rough surface can attract moisture and move the critical rH for the assembly to lower values.

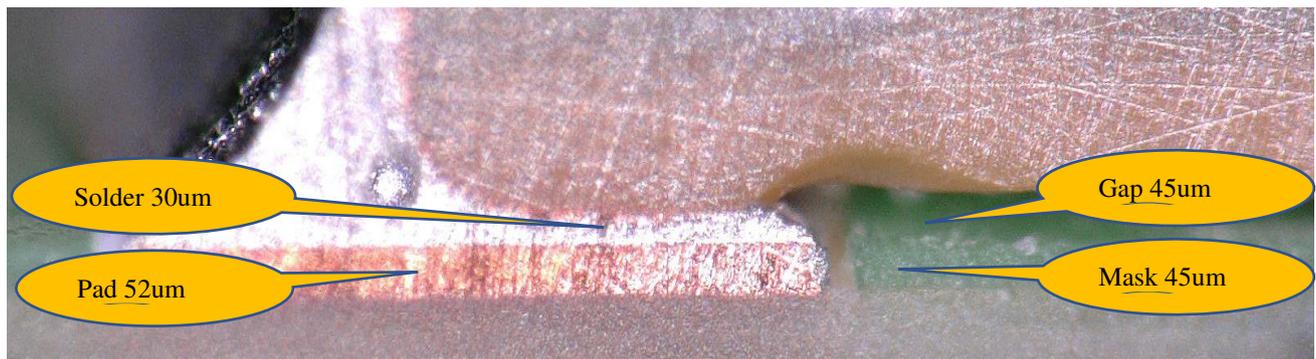
Fig. 11. Gap size under the MLCC

The gap (the space between the package bottom and the substrate surface) is the most critical for cleaning today. With the progress in design packages, the gap becomes thinner and larger. We can estimate the gap thickness from the thickness of the printed solder paste. The primary value is about 50% of a printed thickness (paste has approximately 50% volume of flux, which must leave the solder joint during soldering). Then, the terminal's weight and shape decide the final thickness of the gap..

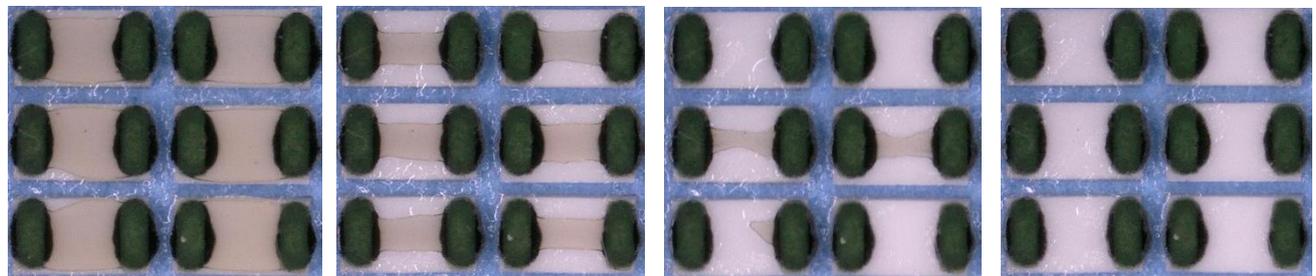
Fig.12. Progress of washing the gap with the Direct spray system

An adequately designed spray-cleaning machine must progress in cleaning the gap from both sides uniformly across the entire working space of the machine. Any inhomogeneity in the cleaning impact can cause prolonging of washing time (washing = first phase of cleaning (dissolving flux residues by the chemistry)

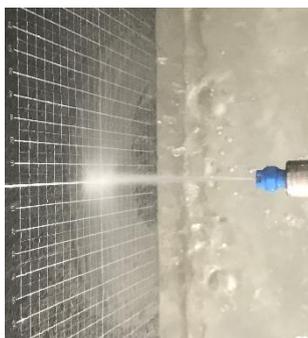
Fig. 13. Streams running along the surface

For spray-in-air cleaning technology, Direct Spray against the surface is the most effective way of agitation. The spray beam brings the kinetic energy up to the surface, and streams of the liquid run from the hitting point to all sides along the board at the best angle to penetrate under components. All shadows due to tall components are suppressed with such an arrangement. Nozzle manifolds are scanning along the board.

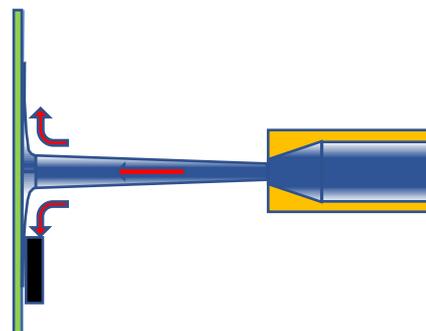
14. Principle of Direct spray with linear scanning along the board

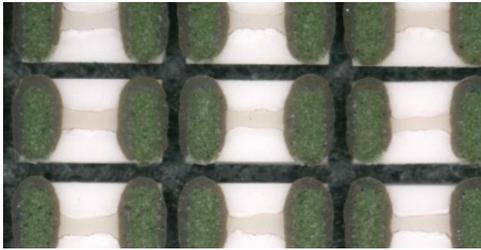
Fig.15 Glass test board with 0805 chips.GTB 400
Cleaning progress

Gap thickness has a prominent influence on the time necessary for cleaning. But not only the thickness is responsible for cleaning success. Also, the gap's area and shape determine the cleaning time and challenge. The following pictures demonstrate the effect of the narrow, long gap.

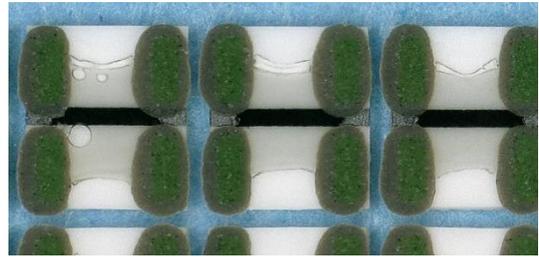
Fig 16. Glass test board with chips 0811GTB200
(the same conditions as Fig. 12)

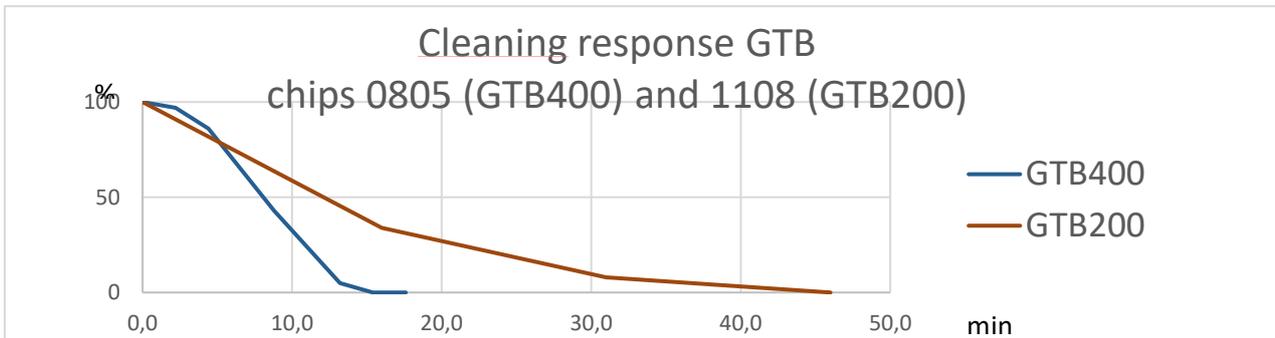
Fig.17. Record of sequential cleaning of test boards with the short and long gaps

By using a short interval sequential cleaning technique (repeated short wash intervals, interruption + measuring of the result on automatic optical inspection), we found that the 2x longer gap needs a 3x longer time to a complete cleaning.

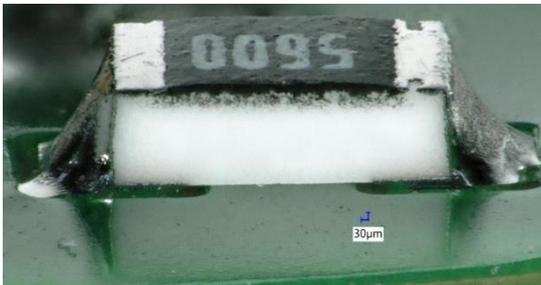
Fig.18. Gap with zero thickness due to high solder mask

Often the gap size is reduced by the improper design of the board or even the component package. A thicker solder mask than the pad is a bare-board manufacturing failure. It can cause too thick solder paste print, smeared print, and in extreme cases, tombstones. Thorough cleaning such a reduced gap under 10-5 um is impossible.

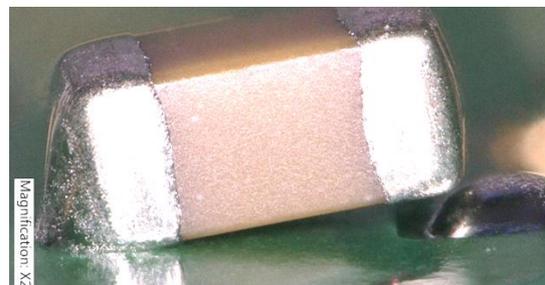
Fig.19.A tombstone due to too thick solder mask

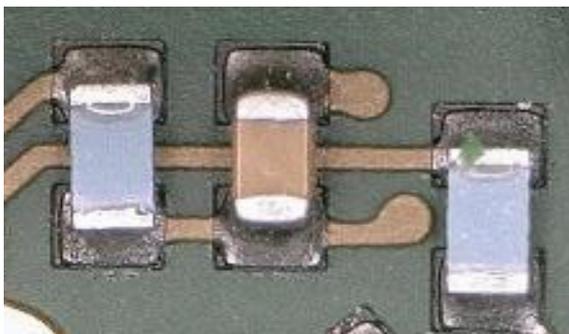
Fig.20 Easy to clean looking assembly.....

It is a standard design feature to draw a track under the component. If we like to optimize the cleaning process, we should avoid that!

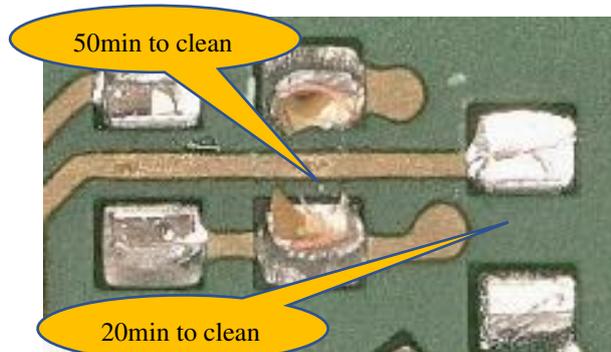
Fig.21.Easy, except for the space with the track

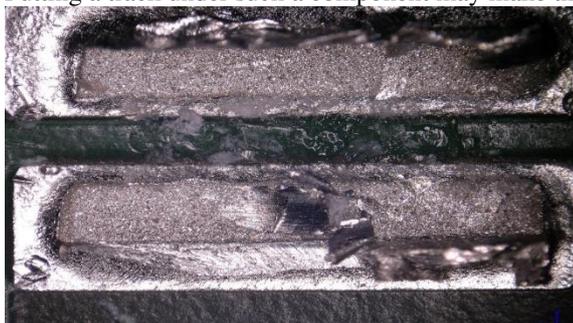
Fig 22. The gap with residues under the reverse geometry chip.

Some passive components have so-called reverse geometry. Cleaning those always needs a longer time. Putting a track under such a component may make the cleaning even more difficult.

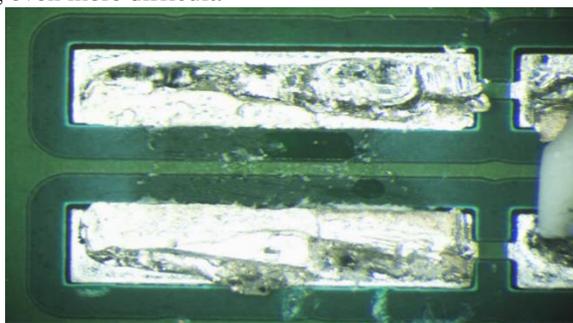
Fig. 23. Line drawn under the reverse geometry chip

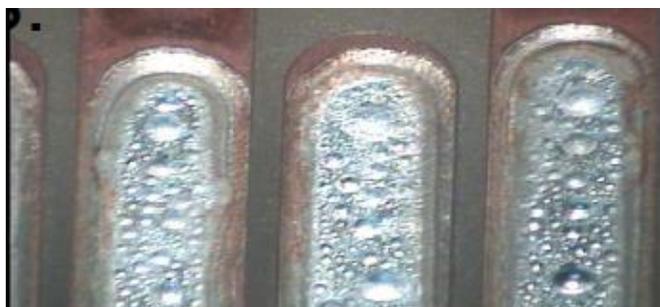
Fig. 24 Solder joints covered by glass

Uncompletely degassed flux residues support the volatility of ions. Such an effect is visible in the result of the demonstration [4] - soldering the comb test board B24 as open and covered with the microscopic cover glass. (Fig. 19, 20,21). Measuring surface insulation resistance shows a significant drop of SIR on the covered solder joint area.

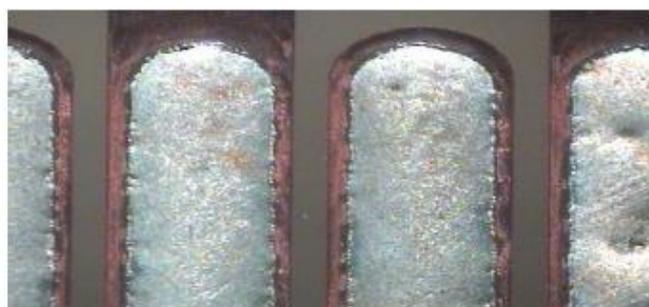
Fig. 25: uncovered solder joints

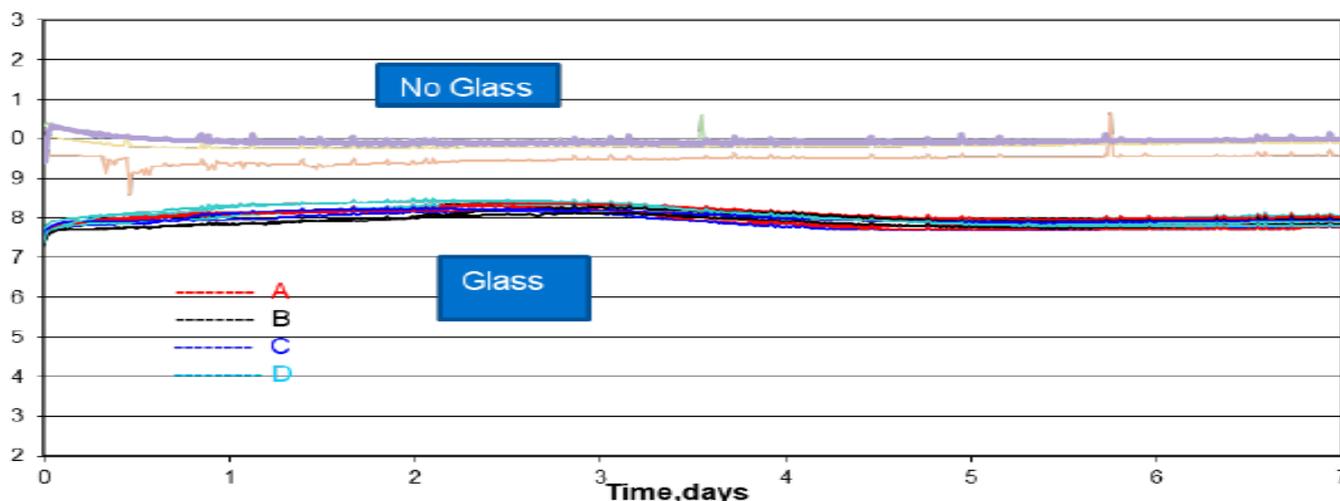
Fig. 26 Drop of SIR due to incomplete degassing of the solder joint.

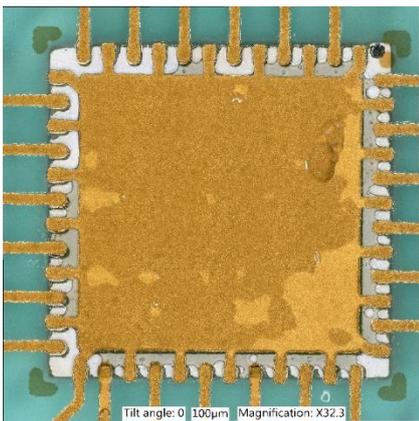
Fig.27 QFN as soldered

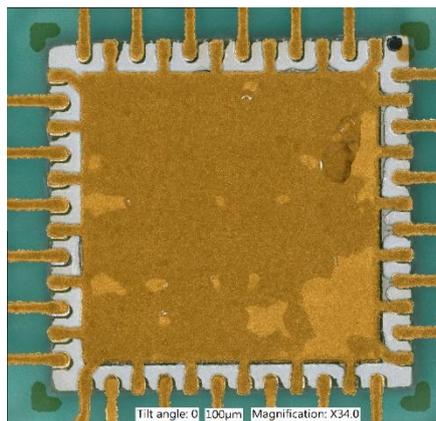
Fig. 28. QFN after cleaning

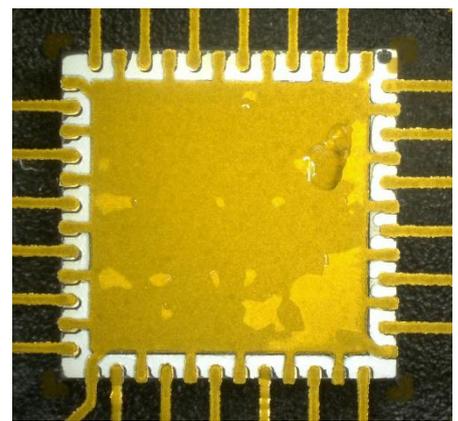
Fig. 29. QFN after SIR test

Both components (QFN44 and FBGA1020) show an acceptable level of SIR after cleaning in our test. The minor solder residues under QFN 44 do not influence the SIR value. (after a 169hr test period)

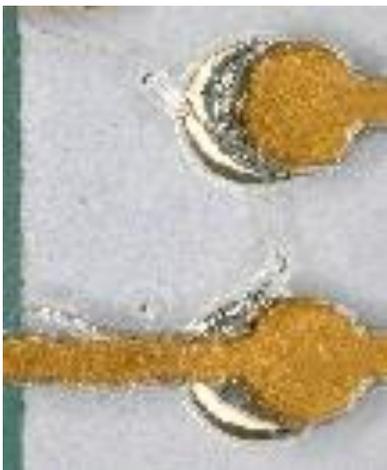
Fig. 30. BGA1020 as soldered

Cleaning BGA is much easier because of the high gap (about 200um). Also, the spaces between terminals (balls) are open from the beginning of the cleaning process. So, cleaning liquid flow under the component is not blocked.

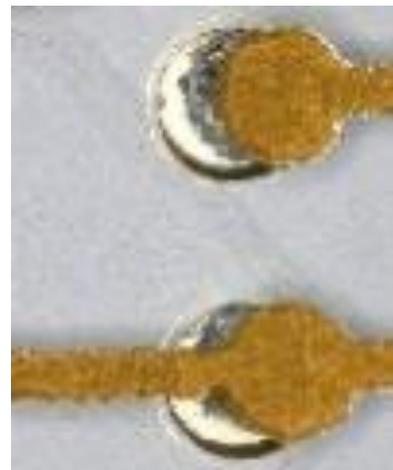
Fig.31. BGA 1020 after cleaning

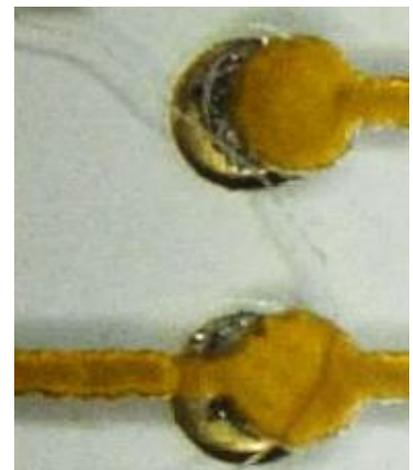
Fig 32. BGA 1020 after the SIR test

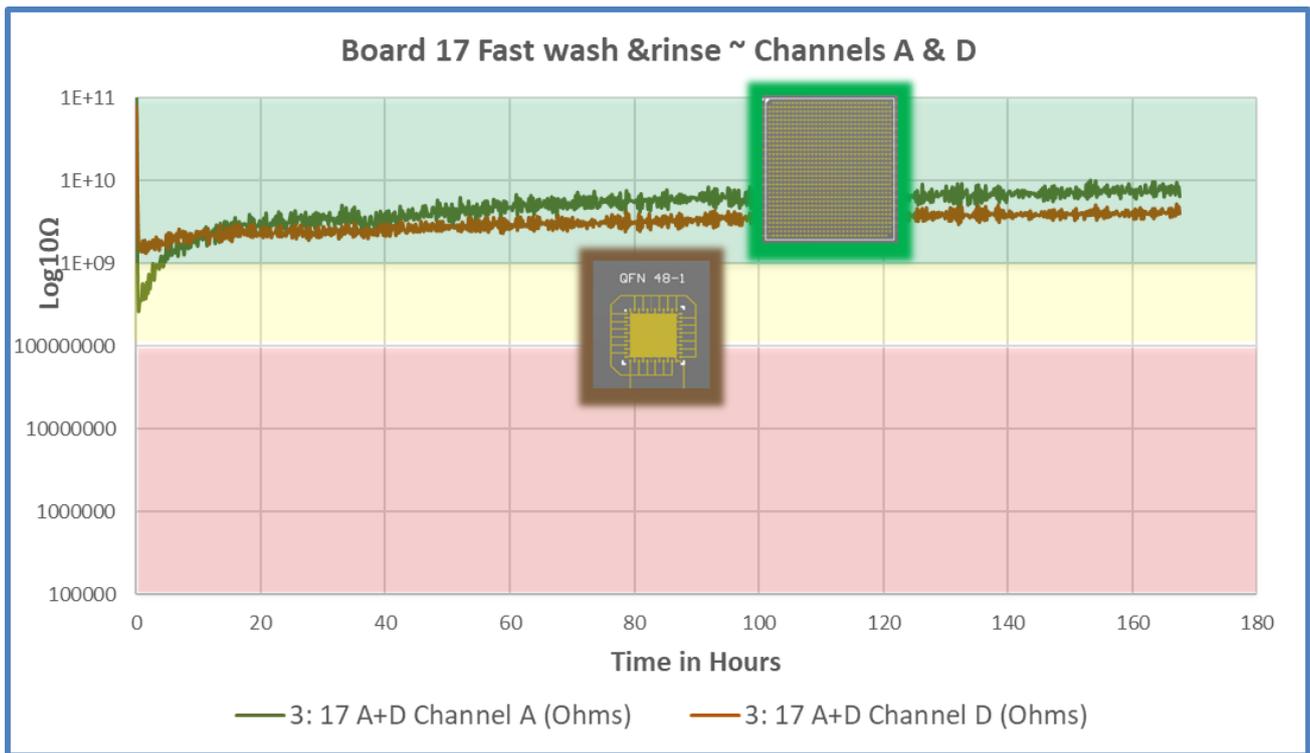
Fig.33: SIR test record of the component on the glass test board

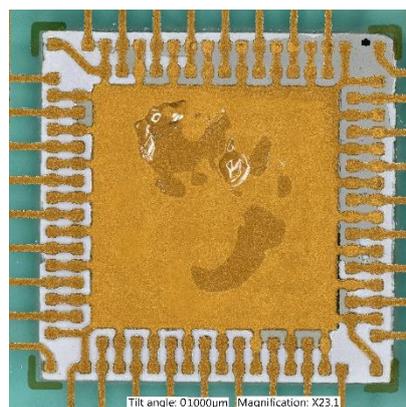
Fig 34. QFN DR 124 before cleaning

The following pictures show a sequence of cleaning progress under QFN DR124. Clearly, in one corner of the package, cleaning progresses very slowly. Gap thickness measuring shows that the critical corner has a gap thickness of only 37um, while the other corners have a much higher value.

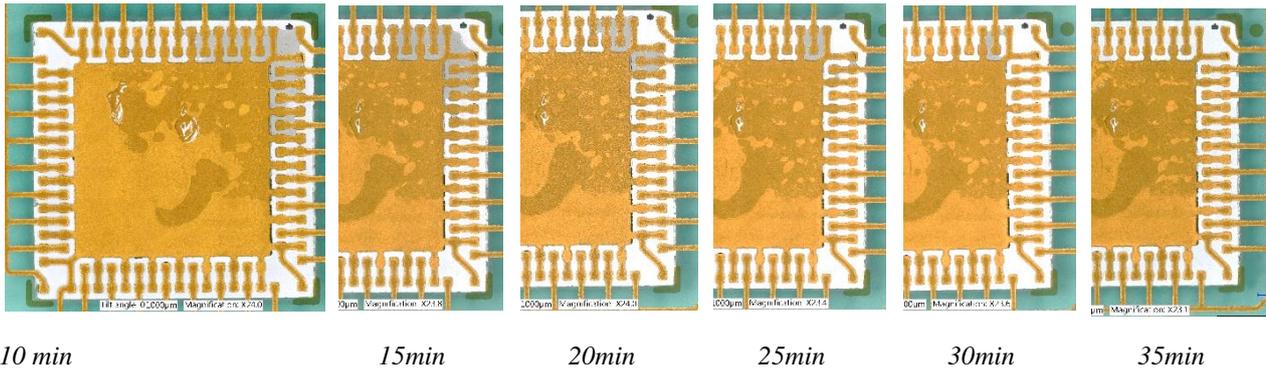
10 min
15 min
20 min
25 min
30 min
35 min
Fig. 35. Cleaning progress of QFN DR124

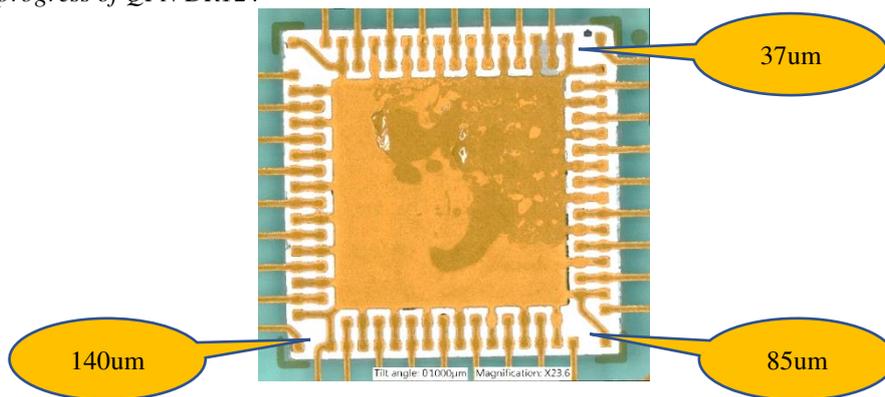
Fig. 36 Gap thickness measuring on the QFN DR124
