# 2.2. Reliability Assessment of Cracks in Ceramic Capacitor in Space Condition

**Tomas Zednicek**

European Passive Components Institute, Czech Republic

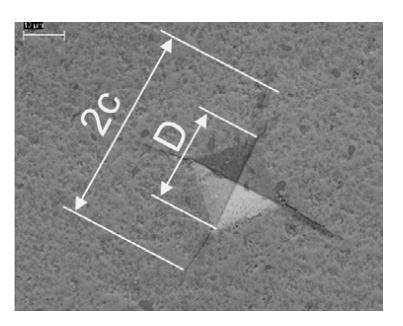
Figure 1. an example of Vickers intender footprint on MLCC body; source Teverovsky NASA [1]

Teverovsky in its NASA paper [1] propose to assess the effect of cracking by pressing the surface with a Vickers indenter. Results showed that cracking does not affect capacitance, which is consistent with the results of flex testing when in many cases capacitance recovers when the stress is removed. The parts electrically passed this test, just dissipation factor showed some sensitivity and increases after cracking by 10 to 50%, but remains within the specified limits.

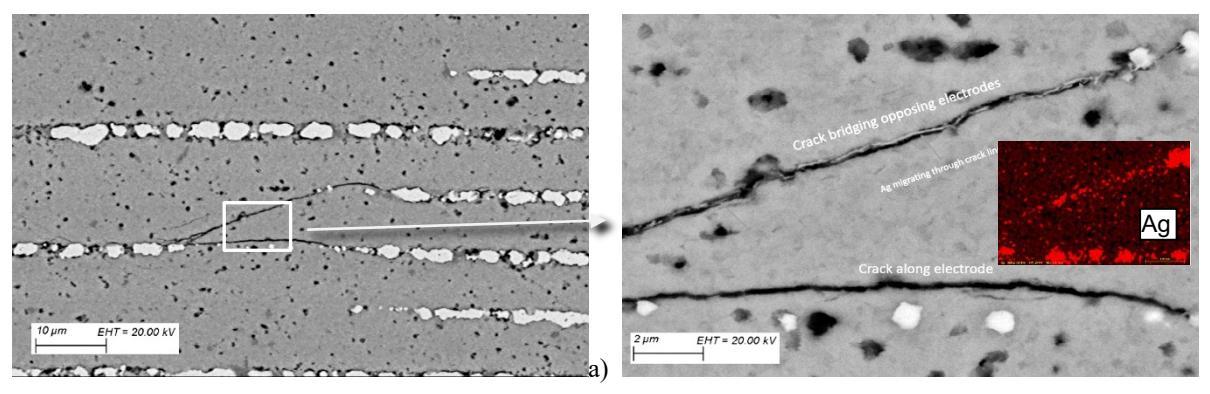
Figure 2. An overall (a) and close-up (b) views of a shorting crack in 0.1  $\mu$ F 16 V PME capacitor. The part was tested at 6 V and started showing increased and unstable leakage currents after 110 hr at room temperature and then failed eventually short circuit due to silver electromigration after 50 hr at 60 °C. source Teverovsky NASA [1]

This resulted in generation of cracks in MLCC capacitors bridging opposing electrodes. The part showed unstable leakage current after 110hr at room temperature and failed short circuit due to electromigration after 50 hours at 60°C. – See Figure 2.

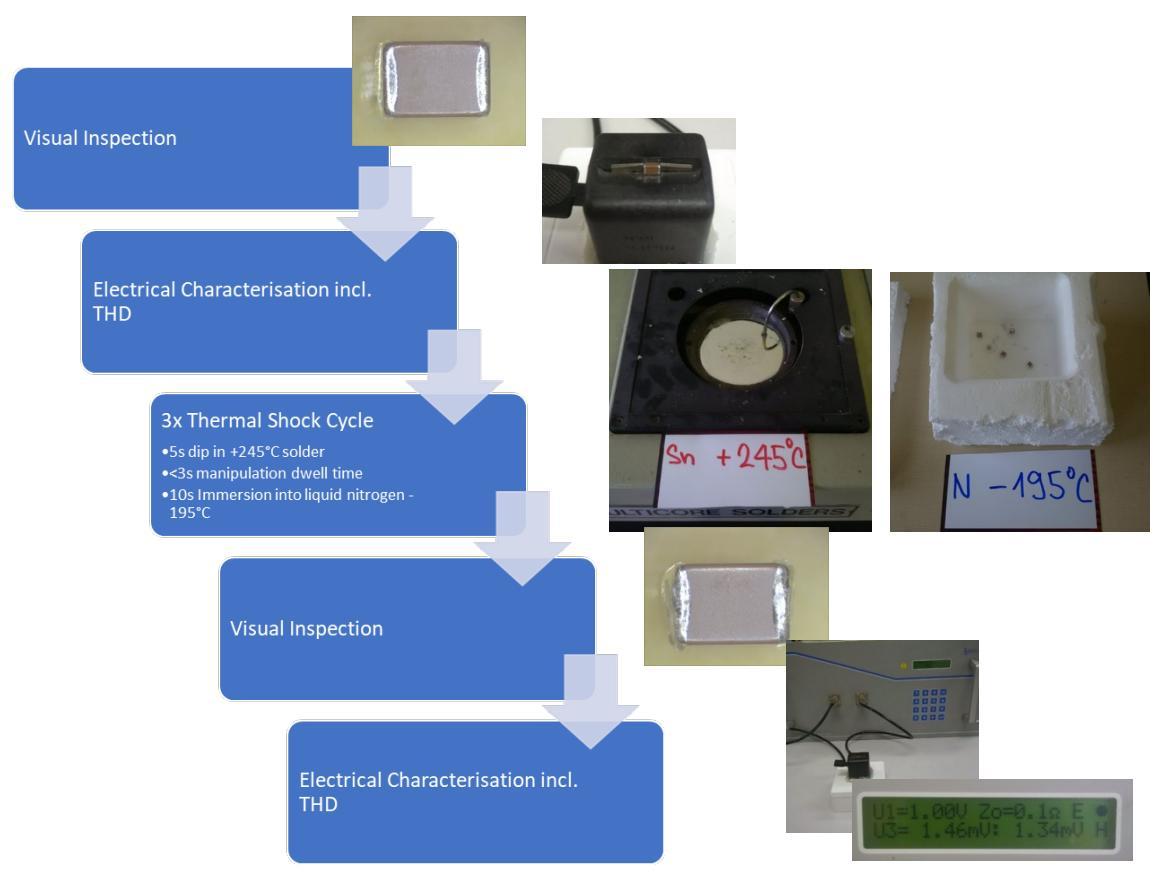
Figure 3. Thermo-mechanical shock test sequence

The first experiment aims to maximize the thermo shock stress. The test sequence consists of visual inspection pre and post test, basic electrical parameters characterization including third harmonic measurement THD and the thermal shock cycle. The thermal shock followed three cycles of dip into hot 245C solder followed by immersion into a liquid nitrogen -195C. Dwell time between the dips were less than 3s – see Figure 3. **Test Flow**

The test following diagram in Figure 3. was performed on 10 parts of MLCC 1812 case samples. The parts were visually inspected under optical microscope.

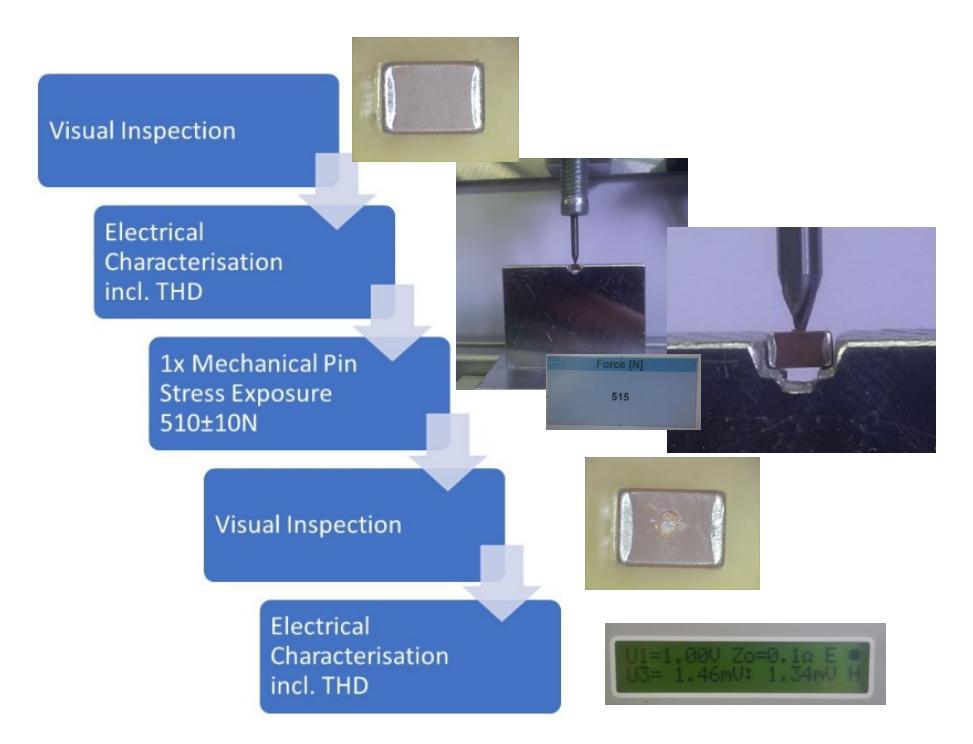
Figure 5. Mechanical pin crack induction test sequence

Sharp mechanical pin was applied from top side to the center of the MLCC body. The pin strength was set to the maximum device capability force:  $510\pm10$  N. The parts were visually inspected under optical microscope and electrically characterized including THD before and after the test – see test flow diagram in Figure 5.

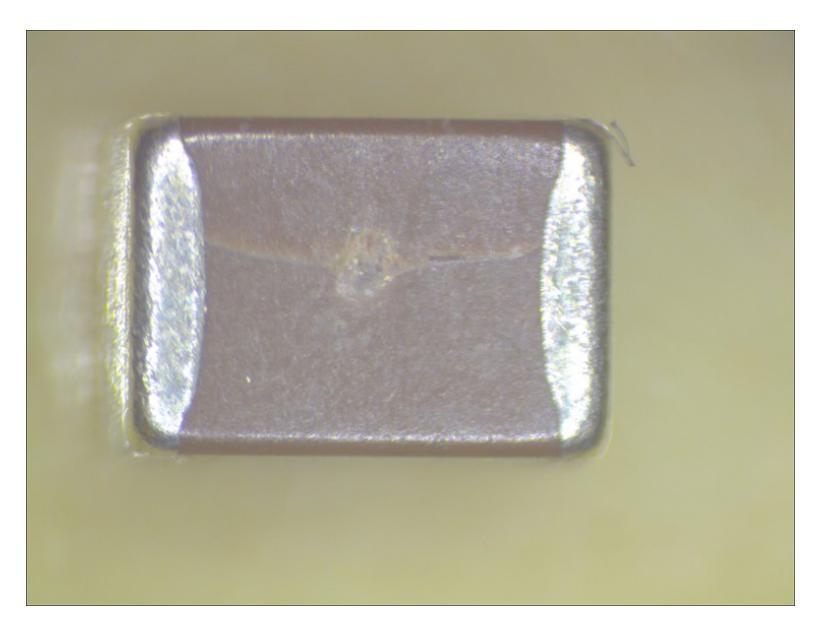
Surface cracks with prolonging microcracks visible on the surface of the MLCC body. Some units crack appeared mildly; others showed markable level of mechanical damage.

Figure 6. Example of surface cracks after the mechanical pin exposure Sample No.6

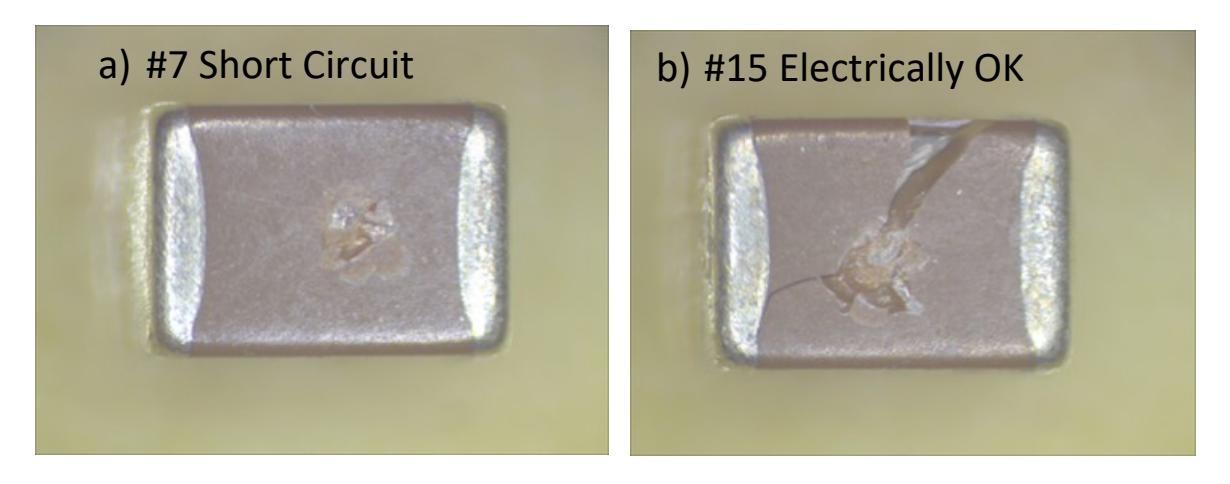
Some MLCC samples were considerably mechanically damaged, nevertheless there is not necessary a direct link between the level of mechanical damage and electrical deterioration / short circuit – see Figure 8.

*Figure 8. MLCC parts after pin exposure a***]** *short circuit sample No.7* **b]** *within electrical specification sample No.15.*

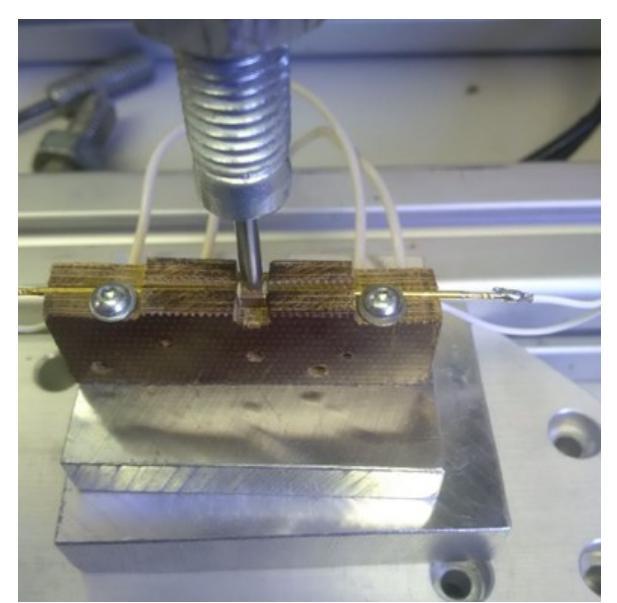
Figure 9. Stress tool modified jig with gold contacts that enable measure of THD during applied force

- 1) Pin stress force varied from 350 to 900N (mechanical equipment was also adjusted to be able to apply even higher stress level)
- 2) Pin shape was changed from low radius (sharp) to high radius (blunt)
- 3) THD was continuously measured during the force applied and values at MAX force recorded.

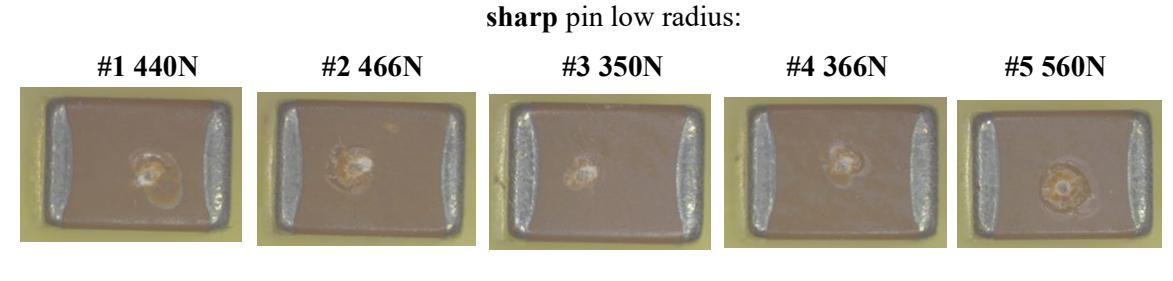
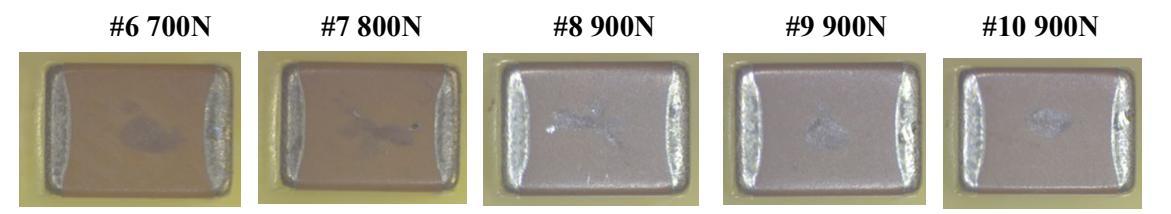
**blunt** pin high radius:

• Low radius sharp pin tool causes a surface damage with microcracks even at lower applied force unlike the blunt tool that even with quite high force 900N did not induced visible surface cracks.

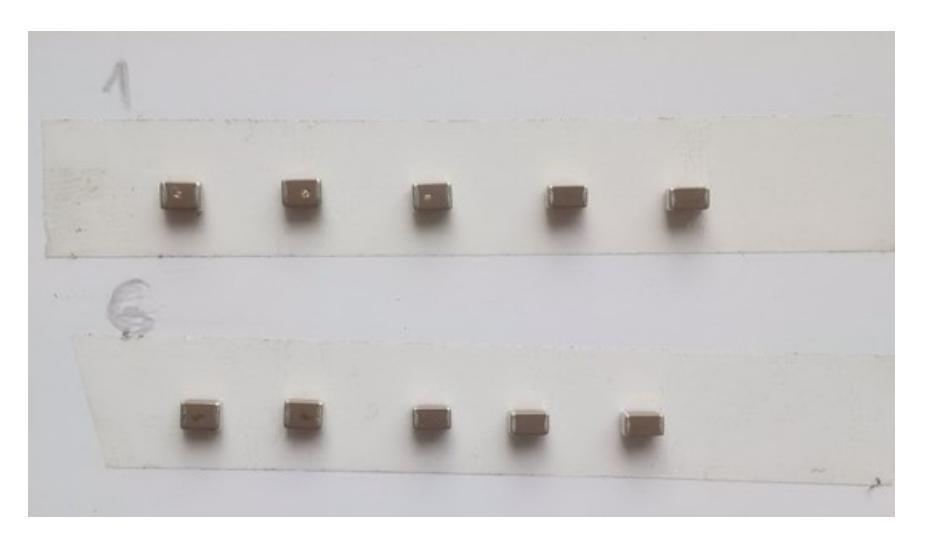
Figure 11. MLCC capacitors sticked to glue tape from top and side for 2D Xray evaluation

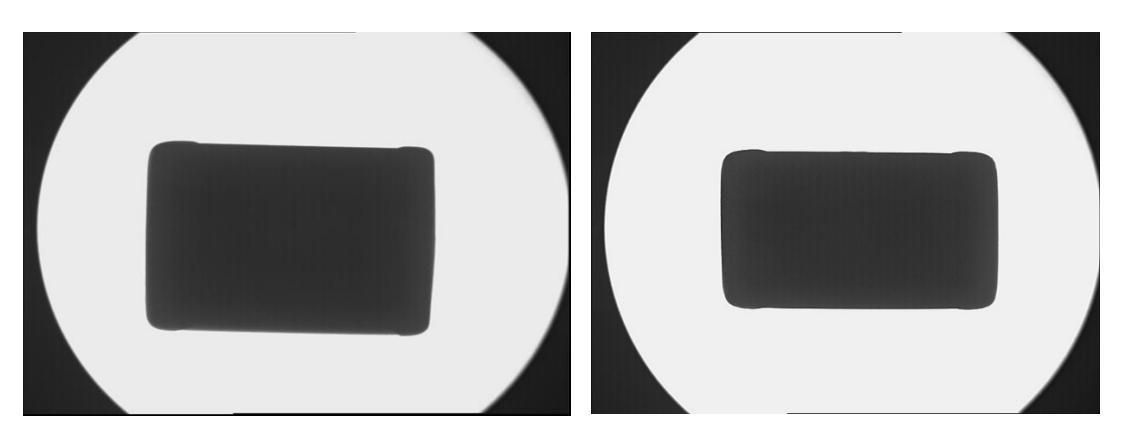
Figure 12. top and side view 2D Xray image of test MLCC capacitors

The 2D Xray images unfortunately could not reveal internal structure of 1812 MLCC capacitors and it may not be suitable for cracks identification.

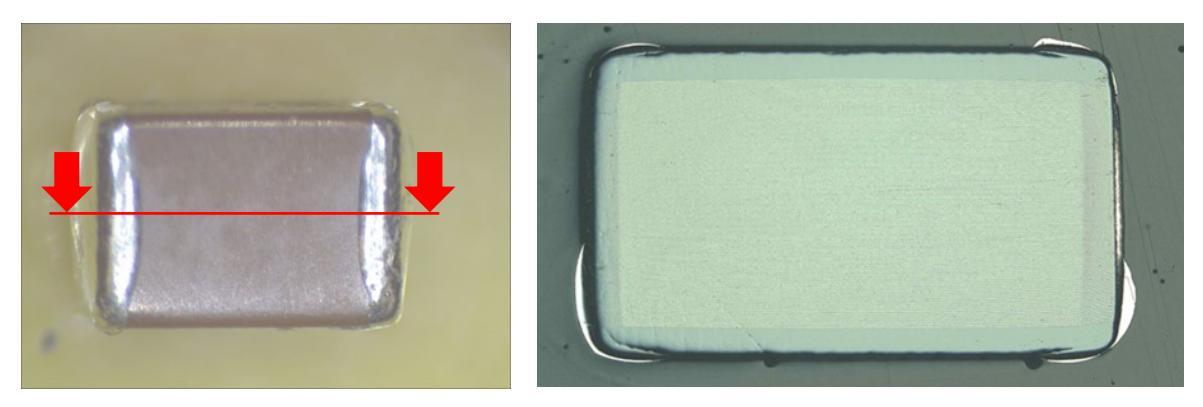
Figure 13. Cross-sectioning Sample No 01 – after thermal shock stress Dt 440°C – Overview

- No cracks neither delamination were detected under the optical microscope examination of all ten samples.
- The MLCC test parts showed very high robustness to thermal shock stress with delta temperature that reach even 440°C. This method may not be suitable to generate cracks in mass scale. "

Ten parts subjected to thermo-mechanical stress test in chapter 3.1. were sectioned and inspected under optical microscope – low and high magnification (x500). See example images of sample No.01 in Figures 13 and 14.

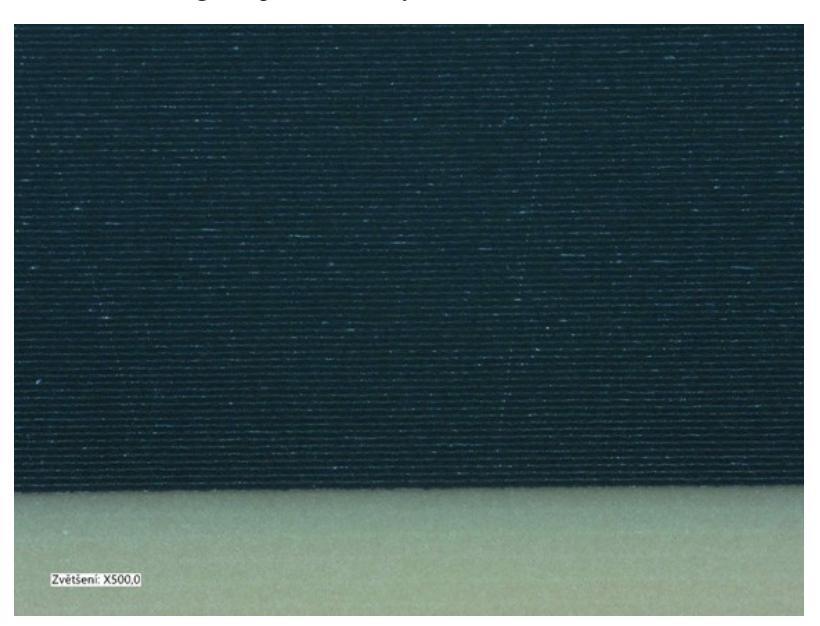
Figure 14. Cross-sectioning Sample No 01 – after thermal shock stress Dt 440°C - Detail

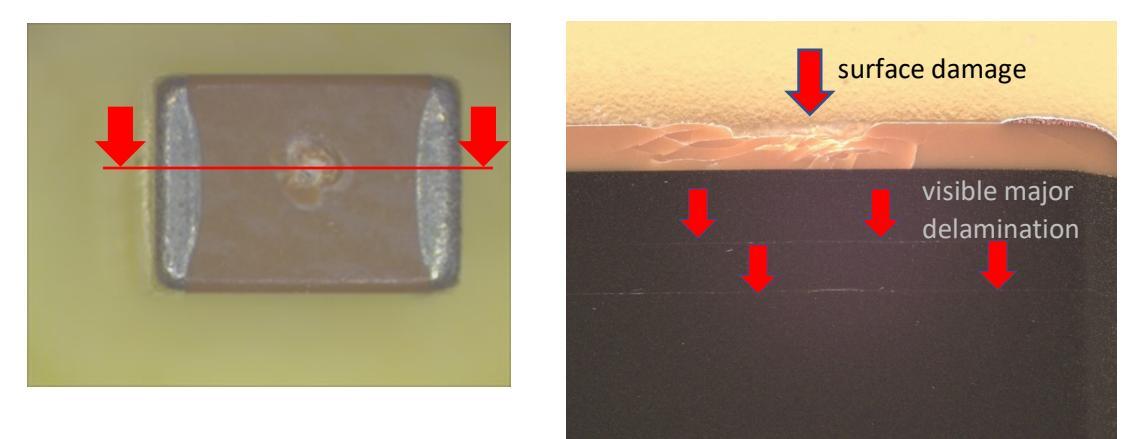
Figure 16. Cross-sectioning Sample No 14 - Sharp pin stress - Overview

Figure 16. to 21. illustrate view of the typical representatives' samples No.14 and 19 cross section images from low to higher magnification.

- The cross-sectioning structure analysis confirms presence of major delamination and cracks inside of the MLCC capacitors subjected to mechanical pin force.
- The delamination present alongside the capacitor body in multiple layers with different length from tenth of millimeters to millimeter range (in some cases up to half size of the MLCC active capacitor zone.
- There is no major difference in inner delamination/crack visual or occurrence frequency between sharp or blunt pin types. The major difference is only level of its surface damage.
- The observed cracks can clearly cross whole dielectric layer thickness from one to the other electrode as shown in Fig.16.

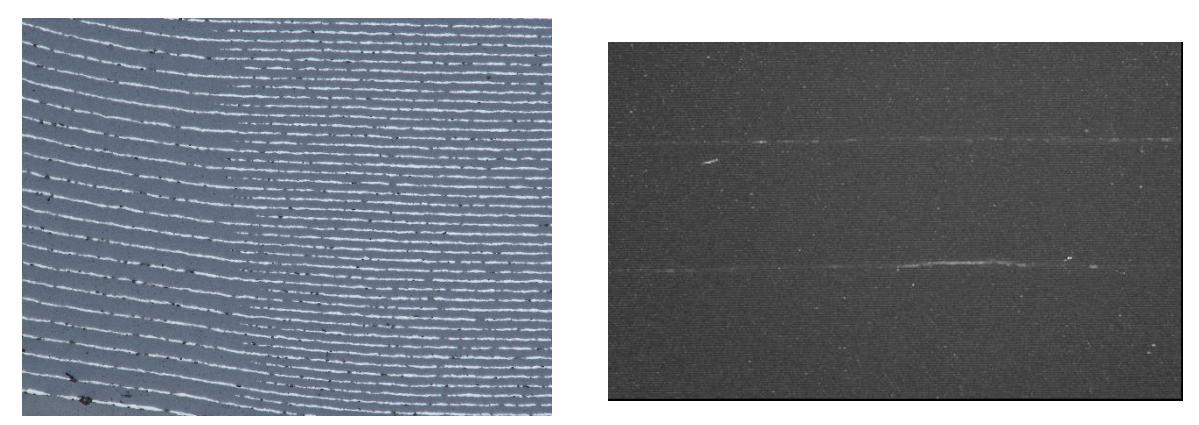
Figure 17. Cross-sectioning Sample No 14 – Sharp pin stress – Detail

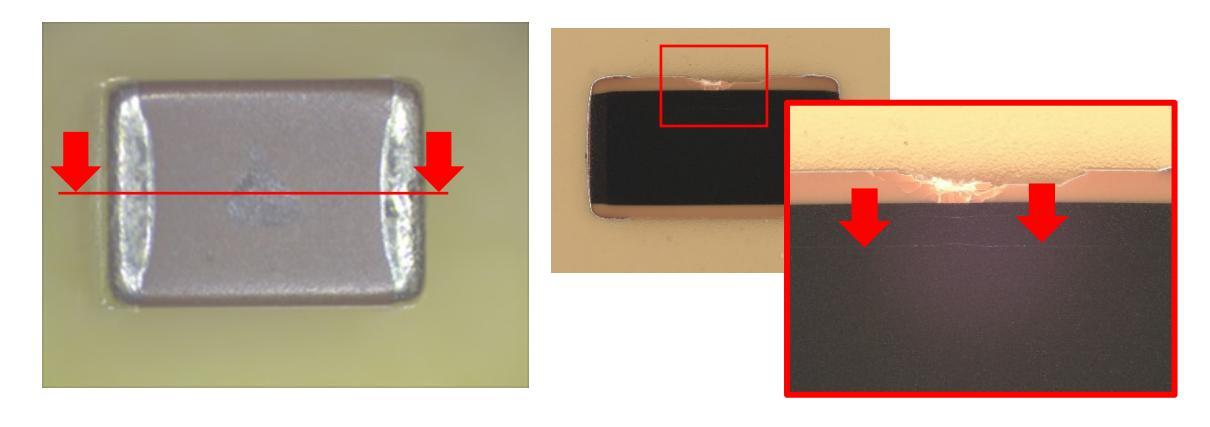
Figure 18. Cross-sectioning Sample No 19 – Blunt pin stress – Overview

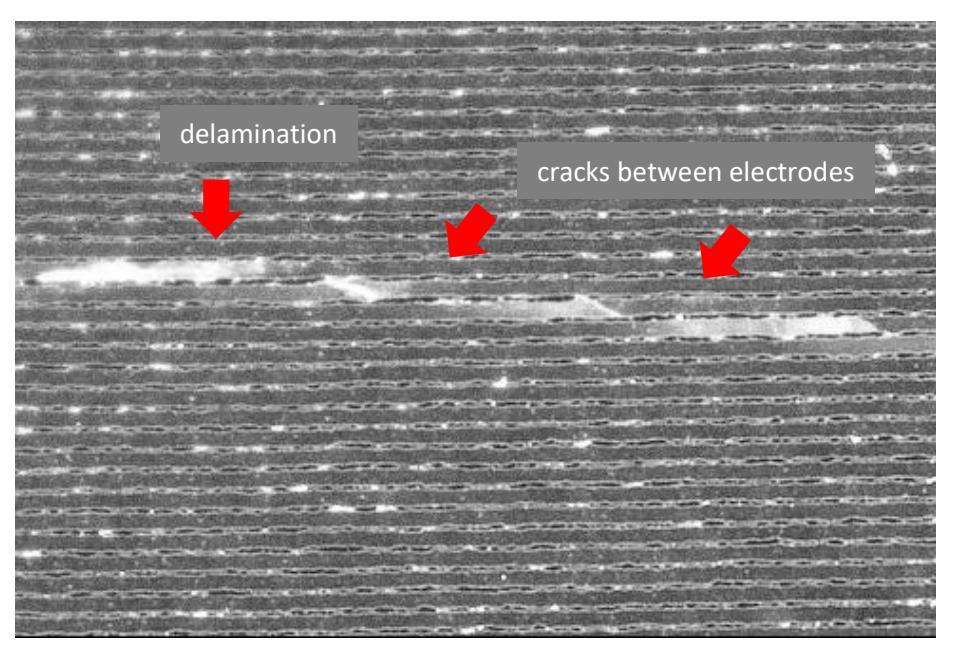
Figure 19. Cross-sectioning Sample No 19 – Blunt pin stress - Detail

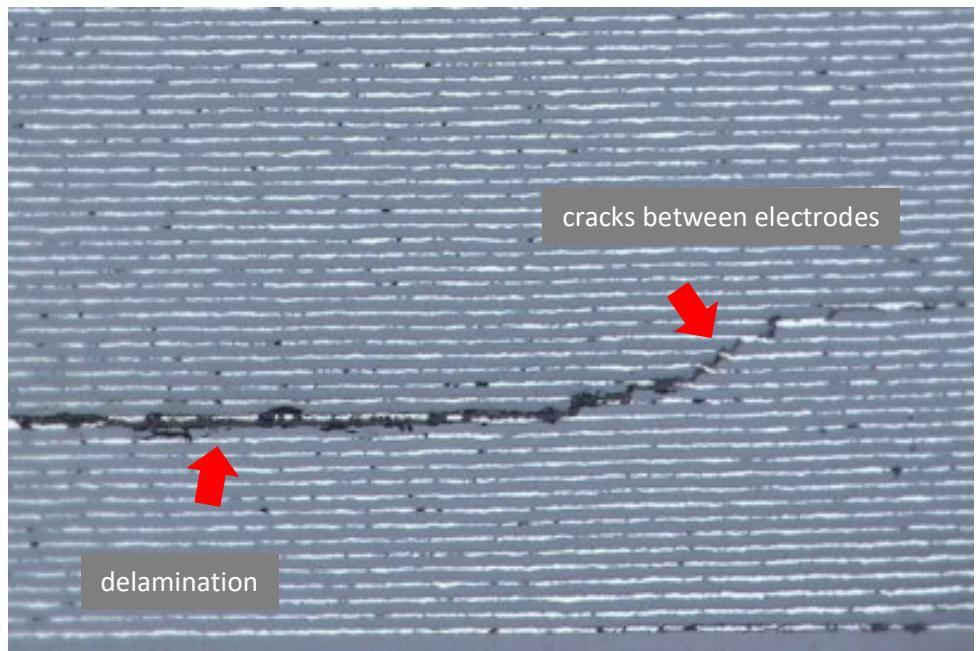
Figure 20. Cross-sectioning Sample No 20 – Blunt pin stress – Detail (normal light)

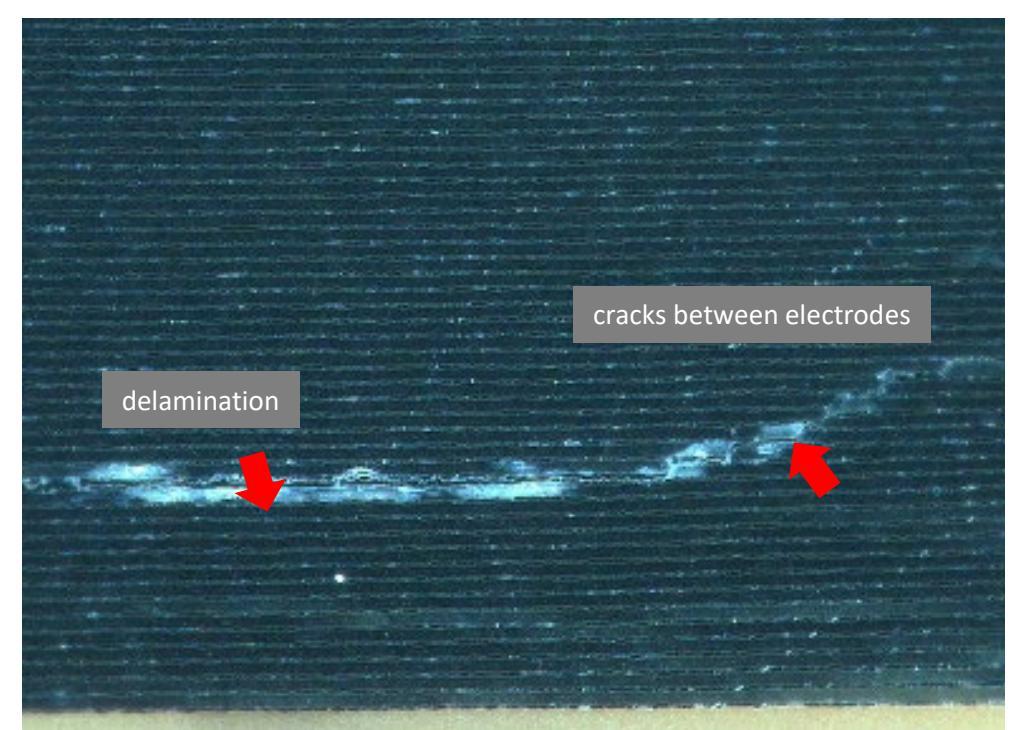
Figure 21. Cross-sectioning Sample No 20 – Blunt pin stress – Detail (polarized light)

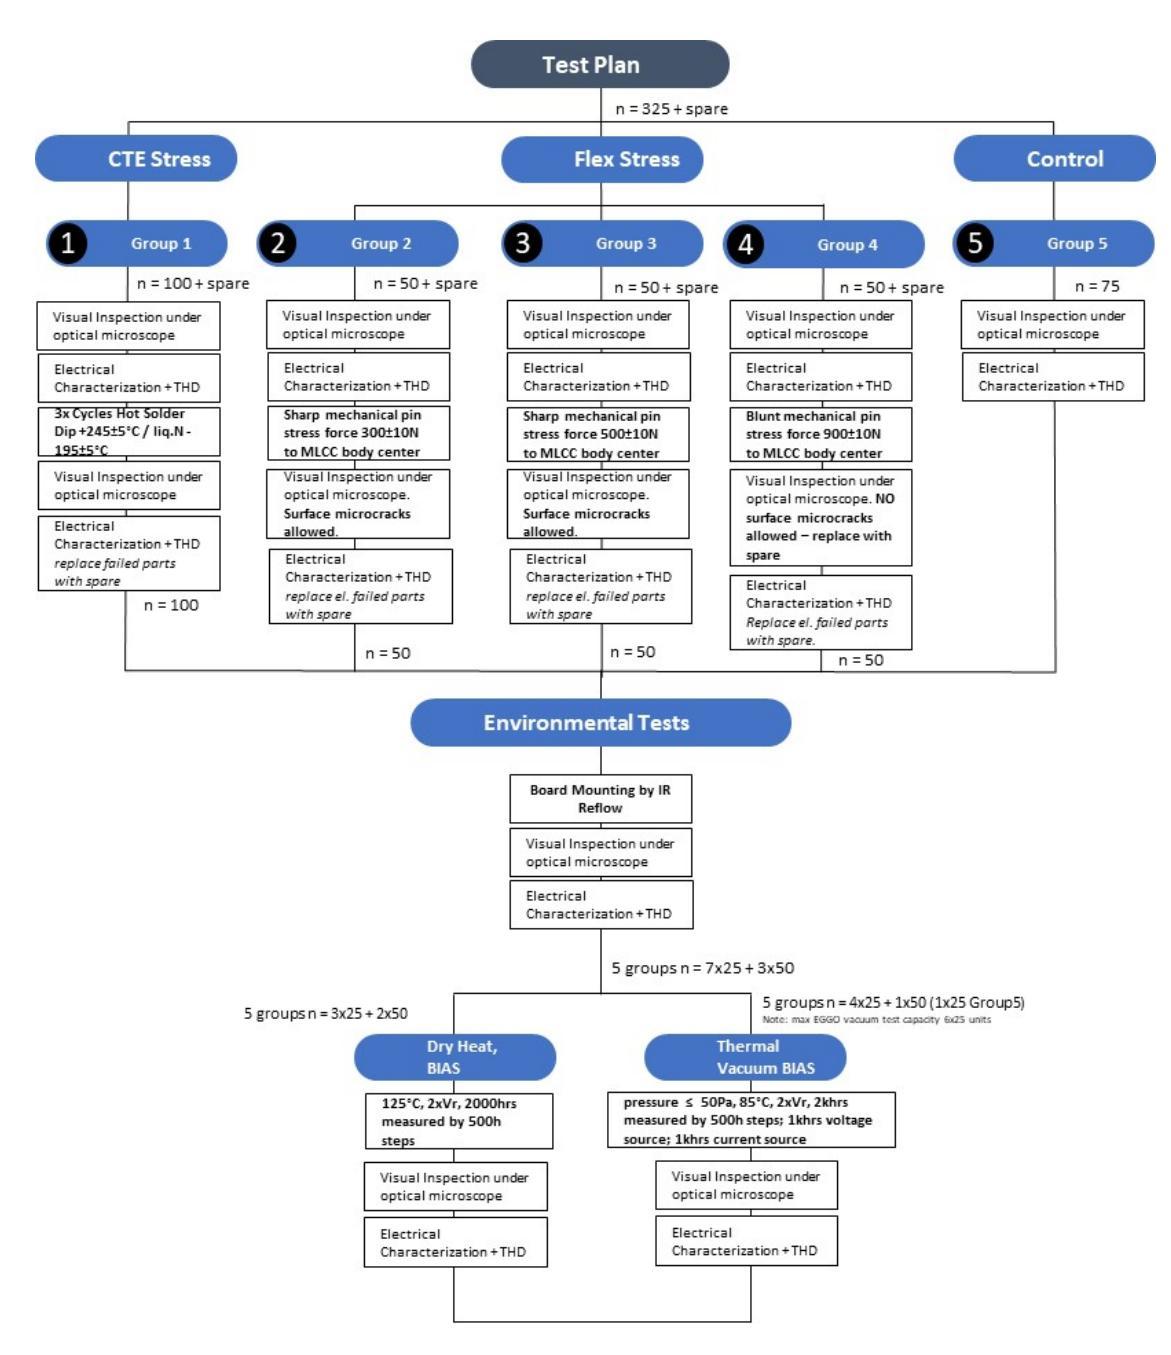
Figure 22. Dry heat and thermal vacuum test flow diagram

The test flow diagram used 350 parts of the MLCC 1812 samples split into five groups - see Figure 22.
